TECHNICAL REPORT #1

January, 22, 2010

Big Meadows Restoration Project, October 14, 2009 Flood Event

Feather River Coordinated Resource Management, Plumas Corporation

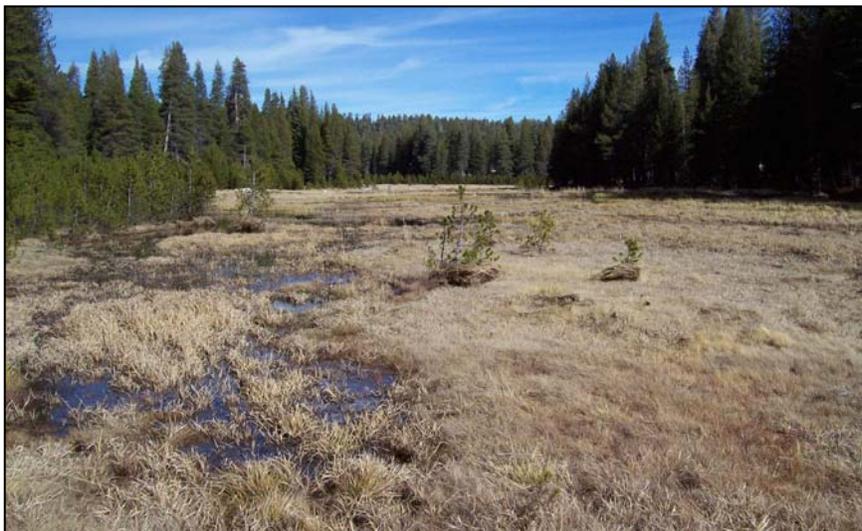
Photo #4. Meadow extent at S/A X-section #1 (11/5/09).

Two cross-sections were surveyed for a slope-area calculation of the peak discharge. The first cross-section was surveyed where the wide meadow narrows near the downstream end of the project (Photos #4 & 5). The second was taken immediately downstream of the end of the project in a natural constriction (photo #6). Water surface widths were 162 ft. and 95 ft., respectively. Average depths were 1.6 ft. and 3.23 ft., respectively.

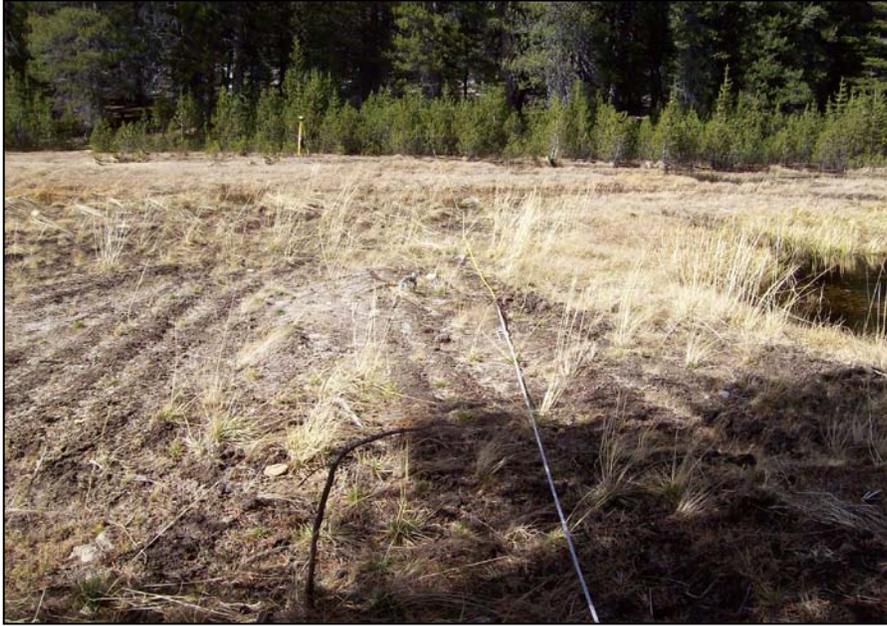
Photo #5. Slope area X-section #1 looking from right to left. Plug in foreground (11/5/09).

Cross-section #1 contained debris deposited at the left high water level and duff scour for the right. Cross-section #2 exhibited duff/soil scour down to conifer roots for the left high water level and debris deposition on the right.

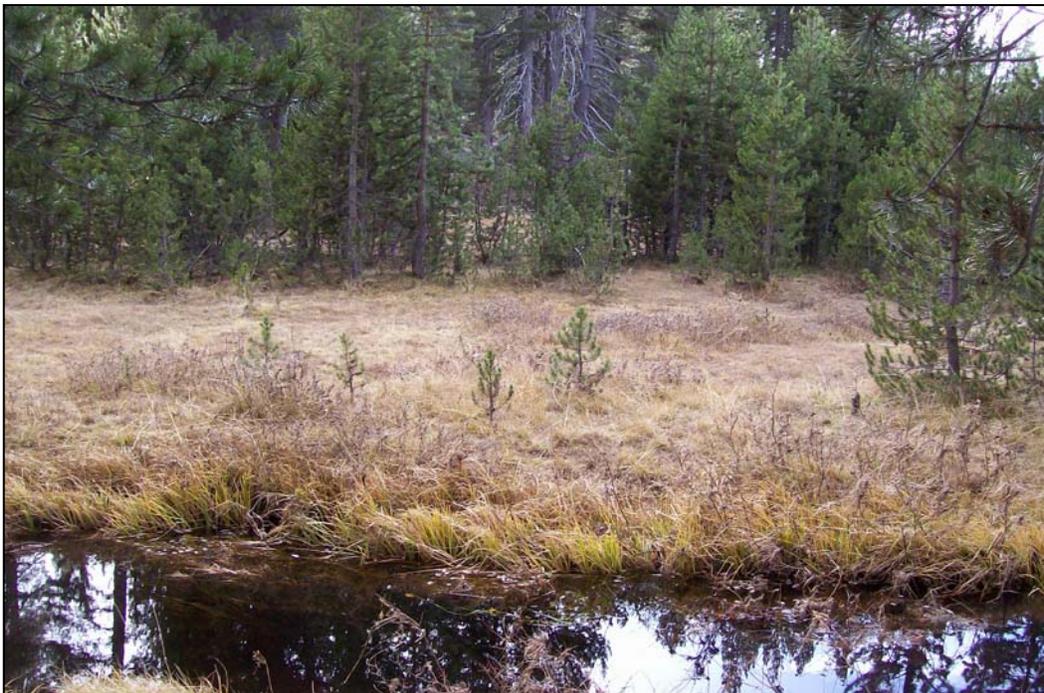
Photo #6. Slope area X-section #2 below project looking from left to right (11/5/09).

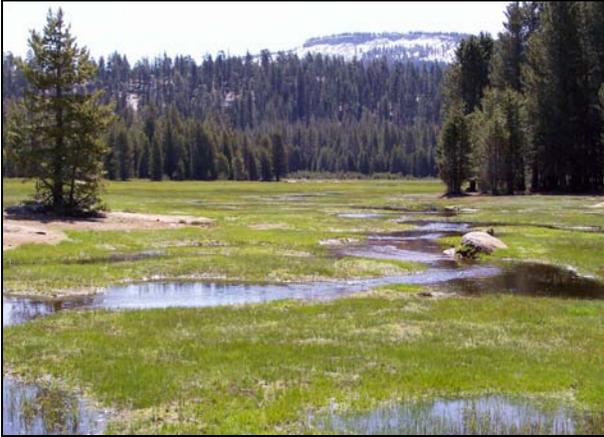
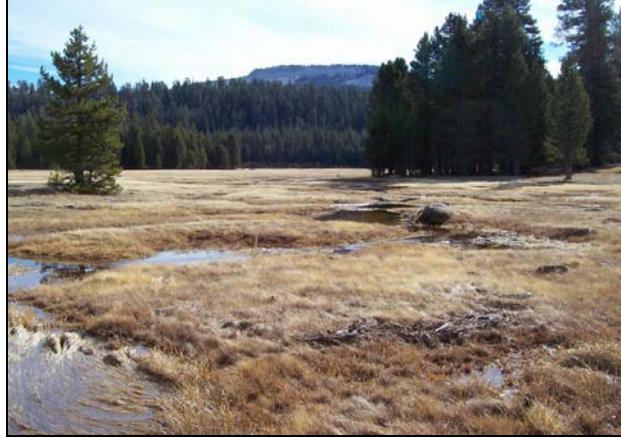
to qualitatively evaluate project performance/response to the event. Photos 7a-f, are from established permanent photo points of the remnant channel system and illustrate strong channel and floodplain stability.

7a. Big Meadows upper meadow remnant- June, 2008

7d. Big Meadows upper meadow remnant- Nov., 2009

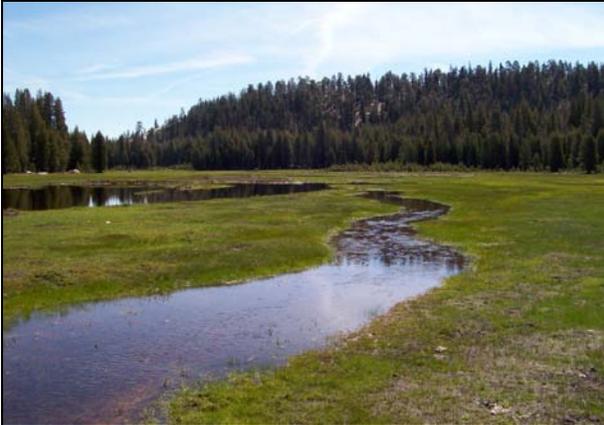
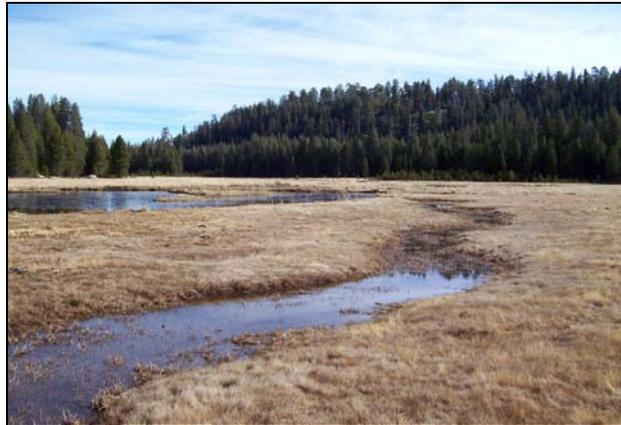
7b. Big Meadows mid-meadow remnant- June, 2008

7e. Big Meadows mid-meadow remnant- Nov., 2009

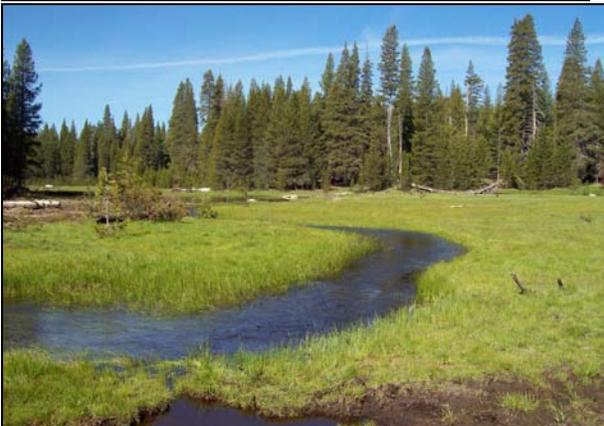
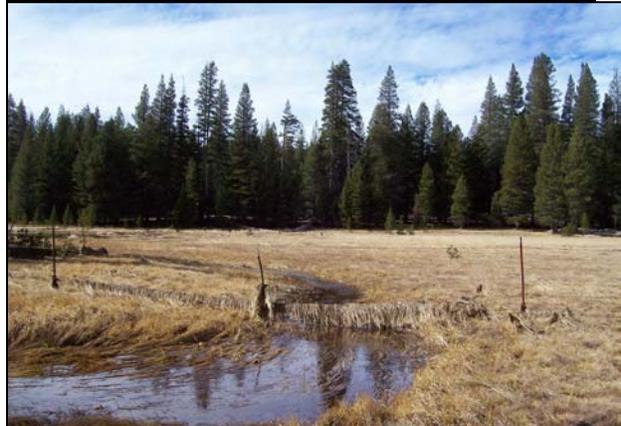
7c. Big Meadows lower meadow remnant- June, 2008

7f. Big Meadows lower meadow remnant- Nov., 2009

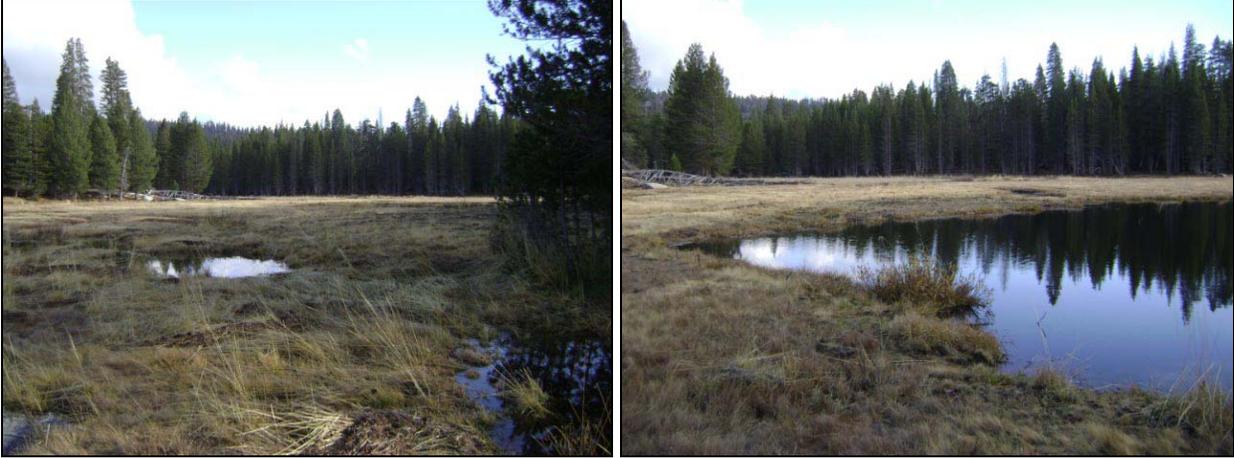
This late dry-season, flash flood-type event occurred when the meadow structures (plugs) were at their most vulnerable. Most ponds in the project area had drained to well below meadow elevation as is normal for early fall. This resulted in a short period of much greater than design elevation differential between plug surfaces and pond water surfaces with an attendant headcut risk. Every plug was examined with no headcuts being located. Additionally, as illustrated in photo series #8a-f below, virtually all plugs sustained some overland flow during this event. Despite depths of up to 2 ft. and velocities up to 3.5 feet

Photos # 8a & b. Upper meadow plug/pond set. Note plug slope and plug/pond vegetation.

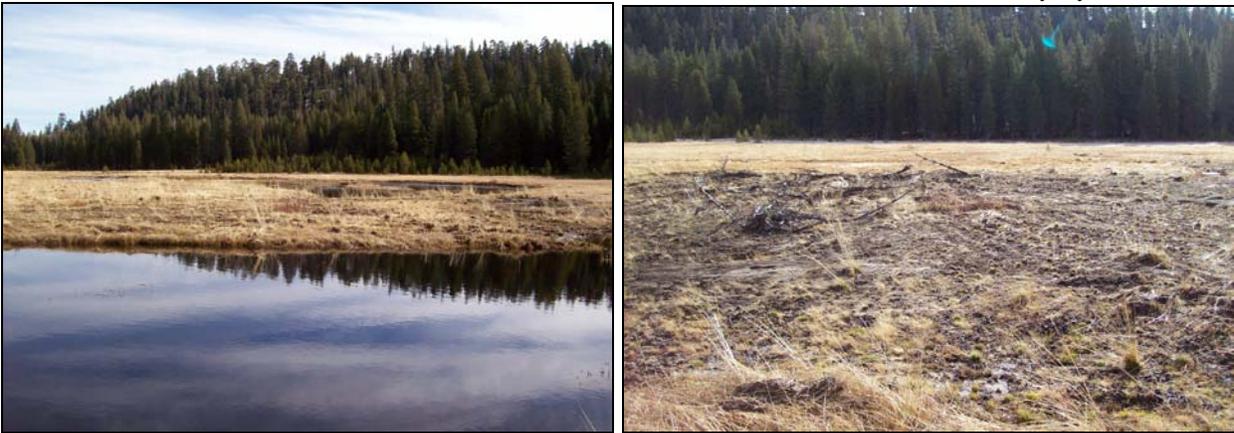
per second (fps), there was very little particle mobilization on any of the plugs. As illustrated in photos 8d and 8f, those particles that were mobilized quickly re-deposited. Even more illustrative is that the tooth drag marks on plugs 8d, e & f were not eroded. This lack of mobility is directly attributable to the properties of dispersed, or sheet, overland flow which minimizes the convergence mechanisms necessary to translate mobilizing velocities to the soil/water boundary.

Photos # 8c & d. Central meadow plugs; left well vegetated, right sparsely vegetated

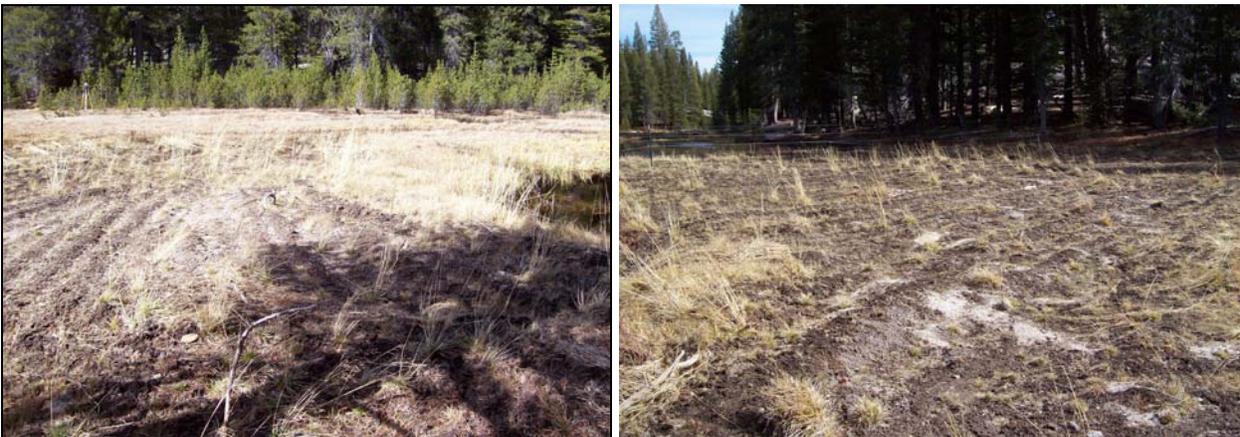
Photos #8e & f. Lower meadow plugs sparsely vegetated; +1' of flow depths.

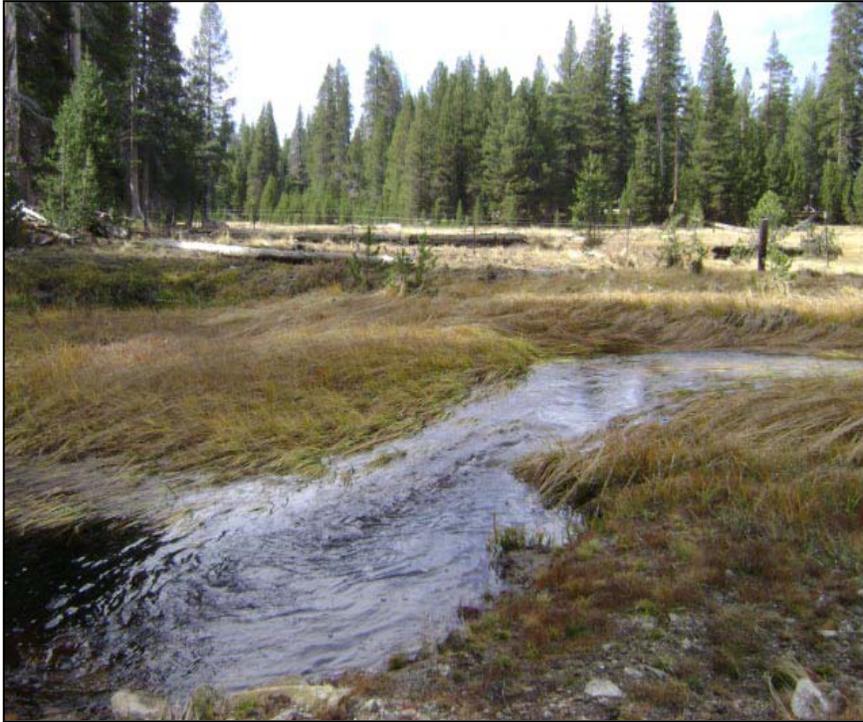
Photo # 9. Lowest valley plug and remnant channel.

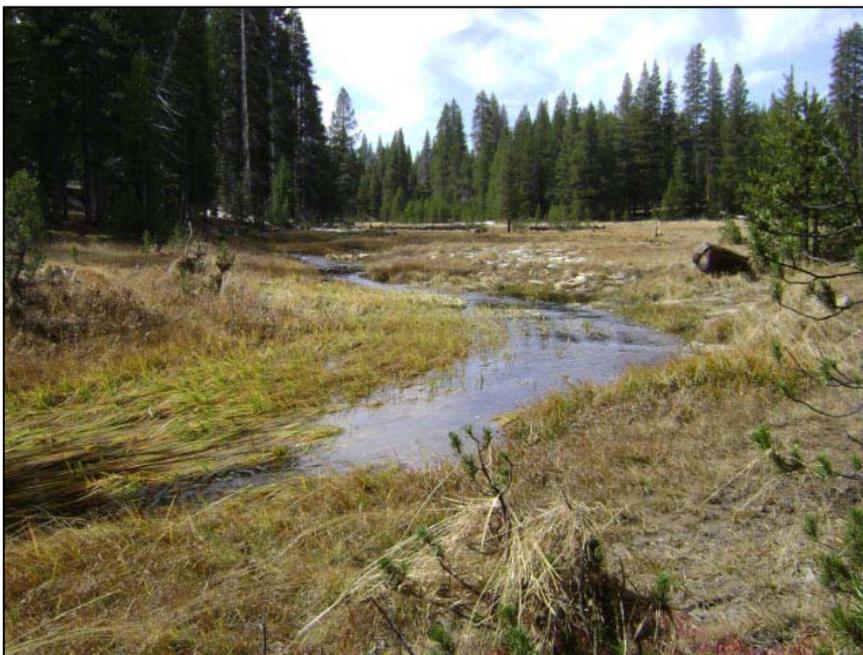
are located at natural landscape constrictions that provide lateral control and restrict all flows to the armored/vegetated structure. The Big Meadow valley grade structure was a relatively simple variant in that the gradient differential was only 2 ft. The floodplain was well vegetated so rock was only needed to raise downstream incised riffle elevations to match the remnant channel grade. Photo #9 shows the lowest plug, post event, left background, with scattered existing large wood and vegetated face. Photo #10 illustrates the valley grade structure, post event, existing channel/floodplain interface.

Photo #10. Existing channel/floodplain interface. Photo by Jayne Ferrante
