Red Clover and Last Chance Creeks Stream Flow Monitoring Report

**Feather River Coordinated Resource Management
Plumas Corporation
May 2012**

This report displays stream flow data collected by the Feather River Coordinated Resource Management group (FRCRM) on Red Clover and Last Chance creeks. This report attempts to display all stream flow data collected on Red Clover and Last Chance creeks to date. There are no conclusions drawn from the data in this report. Further analysis and discussion of the Red Clover data is available in the Red Clover McReynolds Monitoring Reports from 2007-2010. These reports are available on the FRCRM website under the Red Clover McReynolds project tab.

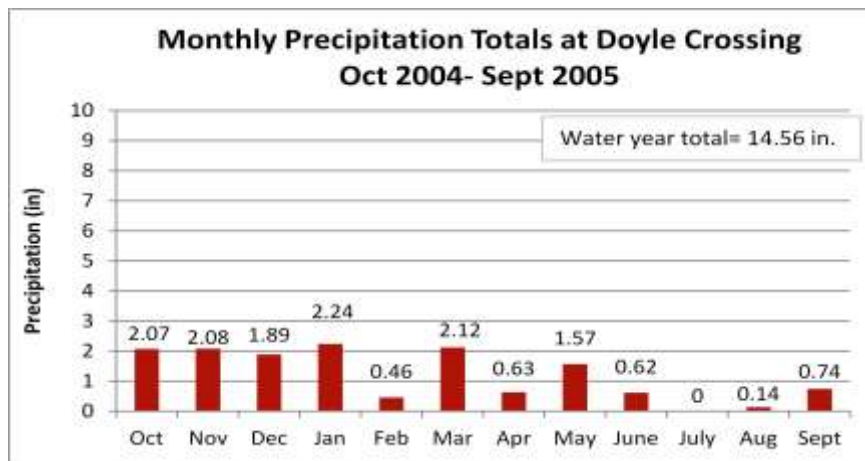
Table 2: Red Clover McReynolds Project Stream Flows (cfs)- 2005

In 2005 stream flow measurement sites were established above, within, and below the Red Clover McReynolds Meadow Restoration Project area. Stream flows were measured at these sites once a month prior to construction in 2006. No continuous stream flow data is available in Red Clover Valley. The closest continuous recording station to Red Clover Valley is on Red Clover Creek at Notson Bridge, approximately 10 miles downstream from the top of the Red Clover McReynolds Project area. Table 2 displays pre-project stream flow data collected in 2005.

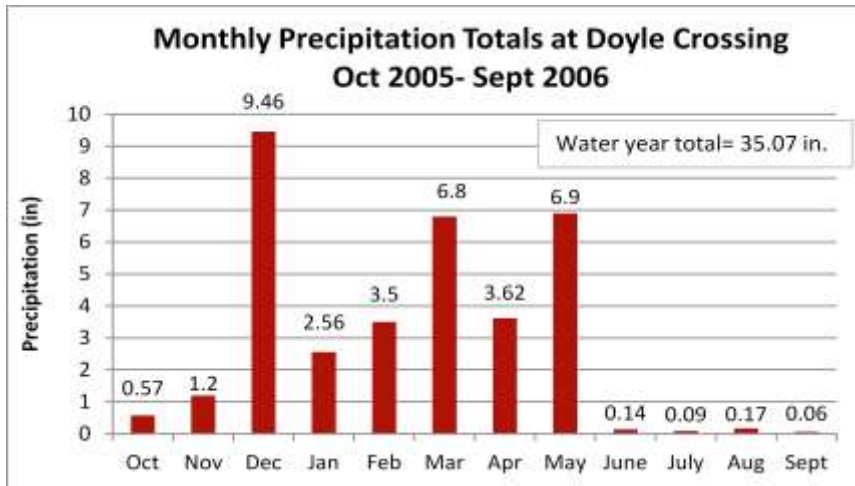
Table 3: Red Clover McReynolds Project Stream Flows (cfs)- 2006

In 2006 the Red Clover McReynolds Meadow Restoration Project was constructed. In 2006 stream flow was only measured once just before project construction commenced.

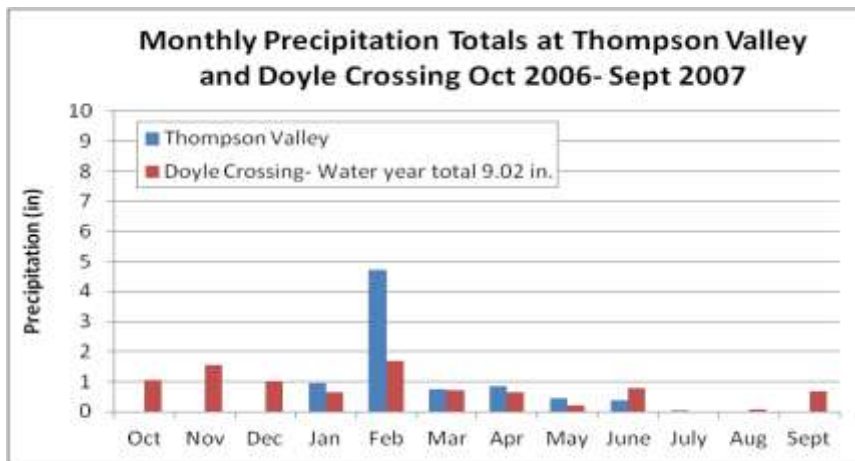
2007 was the first year of post-project stream flow monitoring for the Red Clover McReynolds project. The station above the McReynolds project was moved upstream $\frac{1}{4}$ mile in 2007. The station below the Red Clover McReynolds project was the same as in 2005.

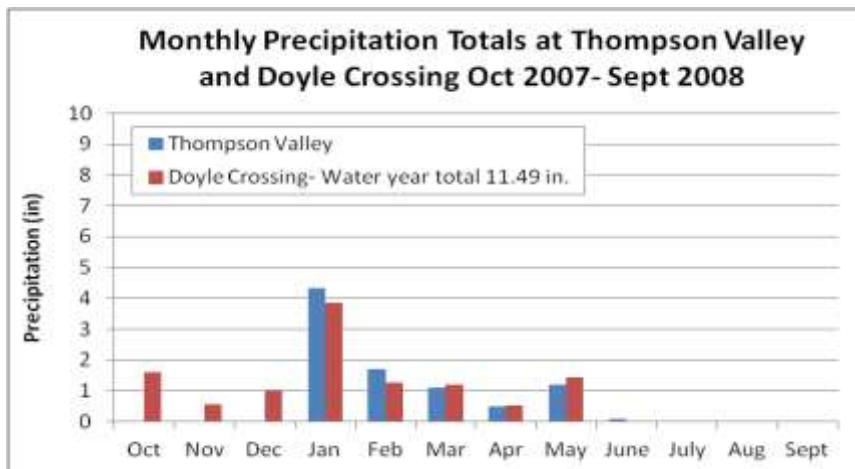
Table 5: Red Clover McReynolds Project Stream Flows (cfs)- 2008

In 2008 the stream flow measurement above the Red Clover McReynolds Project was moved further upstream to above the 1985 check dam project at the Goodwin Ranch barn and corrals. The monitoring station was moved due to beaver interfering with the measurement site. The measurement site below the project was not moved. Stream flow was measured weekly from June through September 2008 compared to monthly in previous years. Notson Bridge continuous recording station had a computer failure in 2008. Stream flow data is only available at Notson Bridge from monthly stream flow measurements rather than continuously.

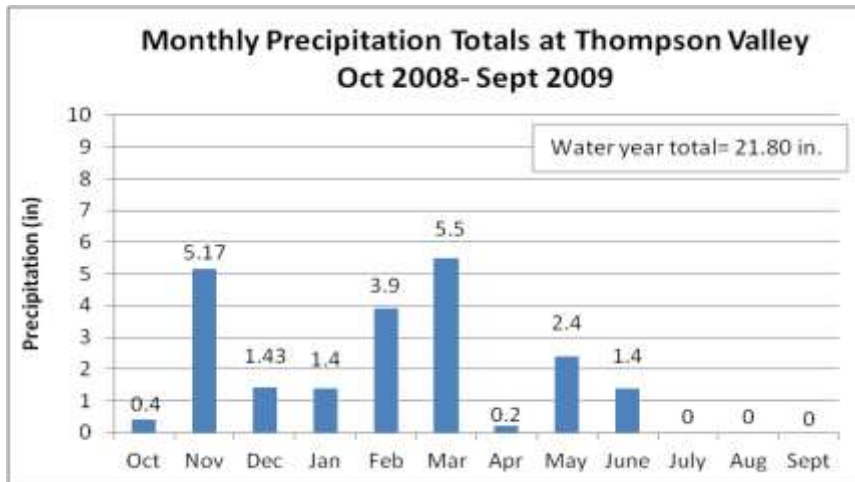
The flow measurement sites stayed the same in 2009 as in 2008. Flow measurements were collected weekly in July through September. The flow measurements at the bottom of the McReynolds project also serve as the inflow and pre-project data for the Red Clover Poco Project constructed in 2010.

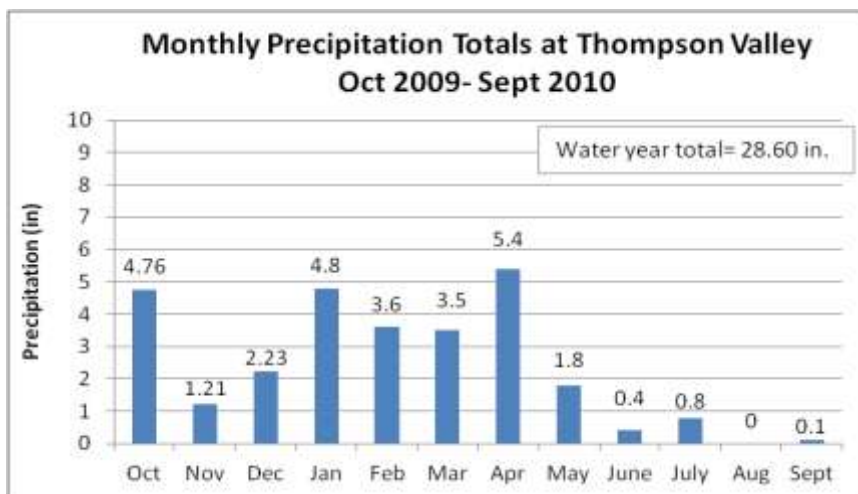
The flow measurement sites remained the same in 2010 as in 2008 and 2009. Flow measurements were collected every other week in August and September. Stream flow coming out of the Red Clover McReynolds project did not reach zero in 2010 as it did in 2007-2009. The flow measurements at the bottom of the McReynolds project also serve as the inflow and pre-project data for the Red Clover Poco Project. Red Clover Poco Project construction began in August 2010. Water started to inundate the bottom flow measurement site, from project construction, in October 2010.
