# **Red Clover/McReynolds Restoration Project Monitoring Final Report**

**Feather River Coordinated Resource Management –  
Plumas Corporation  
January 23, 2008**

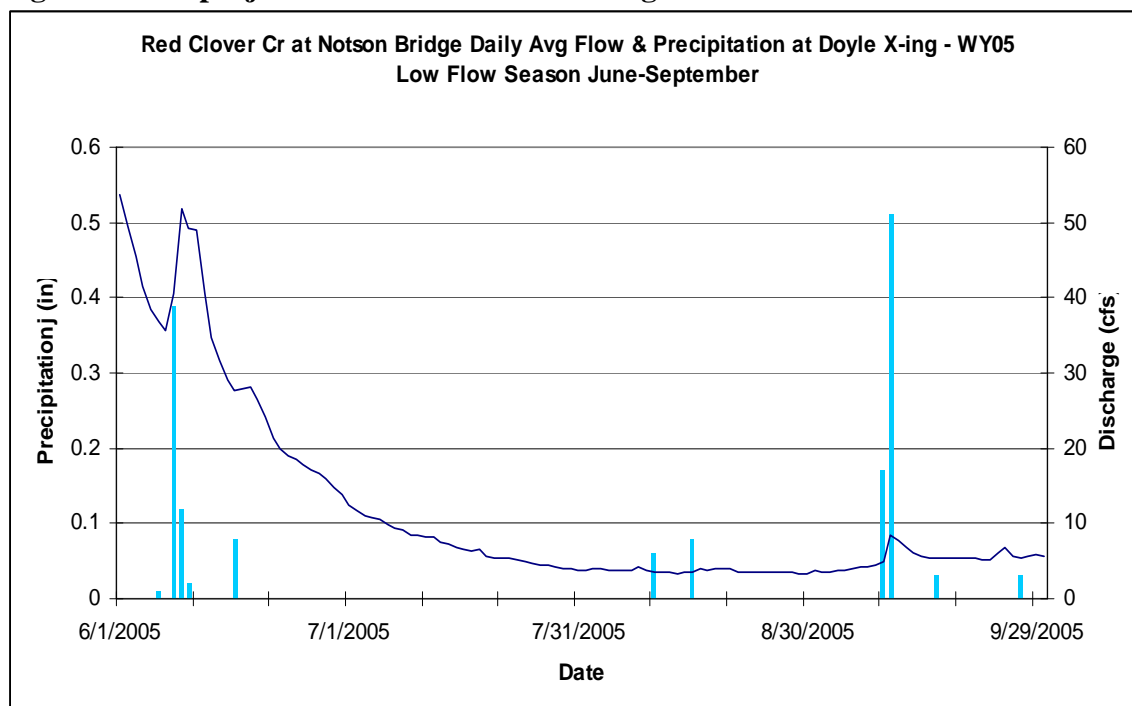
**Figure 3. Pre-project base flow at Notson Bridge.**

There were two measurement efforts to answer this question. The first effort was at Notson Bridge, located nine miles downstream of the project area at the FRCRM's continuous recording station, which has been operating since 1999. Flows at this station, however, also include several tributary channels, and project effects on flow may be washed out by the time flows reach this station. Figure 3 displays pre-project base flow at this station. Figure 4 displays post-project base flow at this station. Both graphs also display precipitation. Because the 2007 data is so recent, it has not been corrected, and should not be quoted. (Although, the data are probably adequate for gross comparisons between years.) Pre-project flows were measured in 2005, with 88% of normal precipitation. Post-project flows were measured in 2007, with 76% of normal precipitation. The percent of normal figure is from the Portola station on the Calif. Data Exchange Center website.

The expectation is that the 2007 data would show an increase in base flow due to the project. However, the lack of precipitation caused a dramatic drop in base flow between these years. Comparison between these years is not valid at this time due to the extreme difference in flows and precipitation. Hopefully, the upcoming winter will provide more normal precipitation for a better comparison of pre- and post-project flow conditions at Notson Bridge.

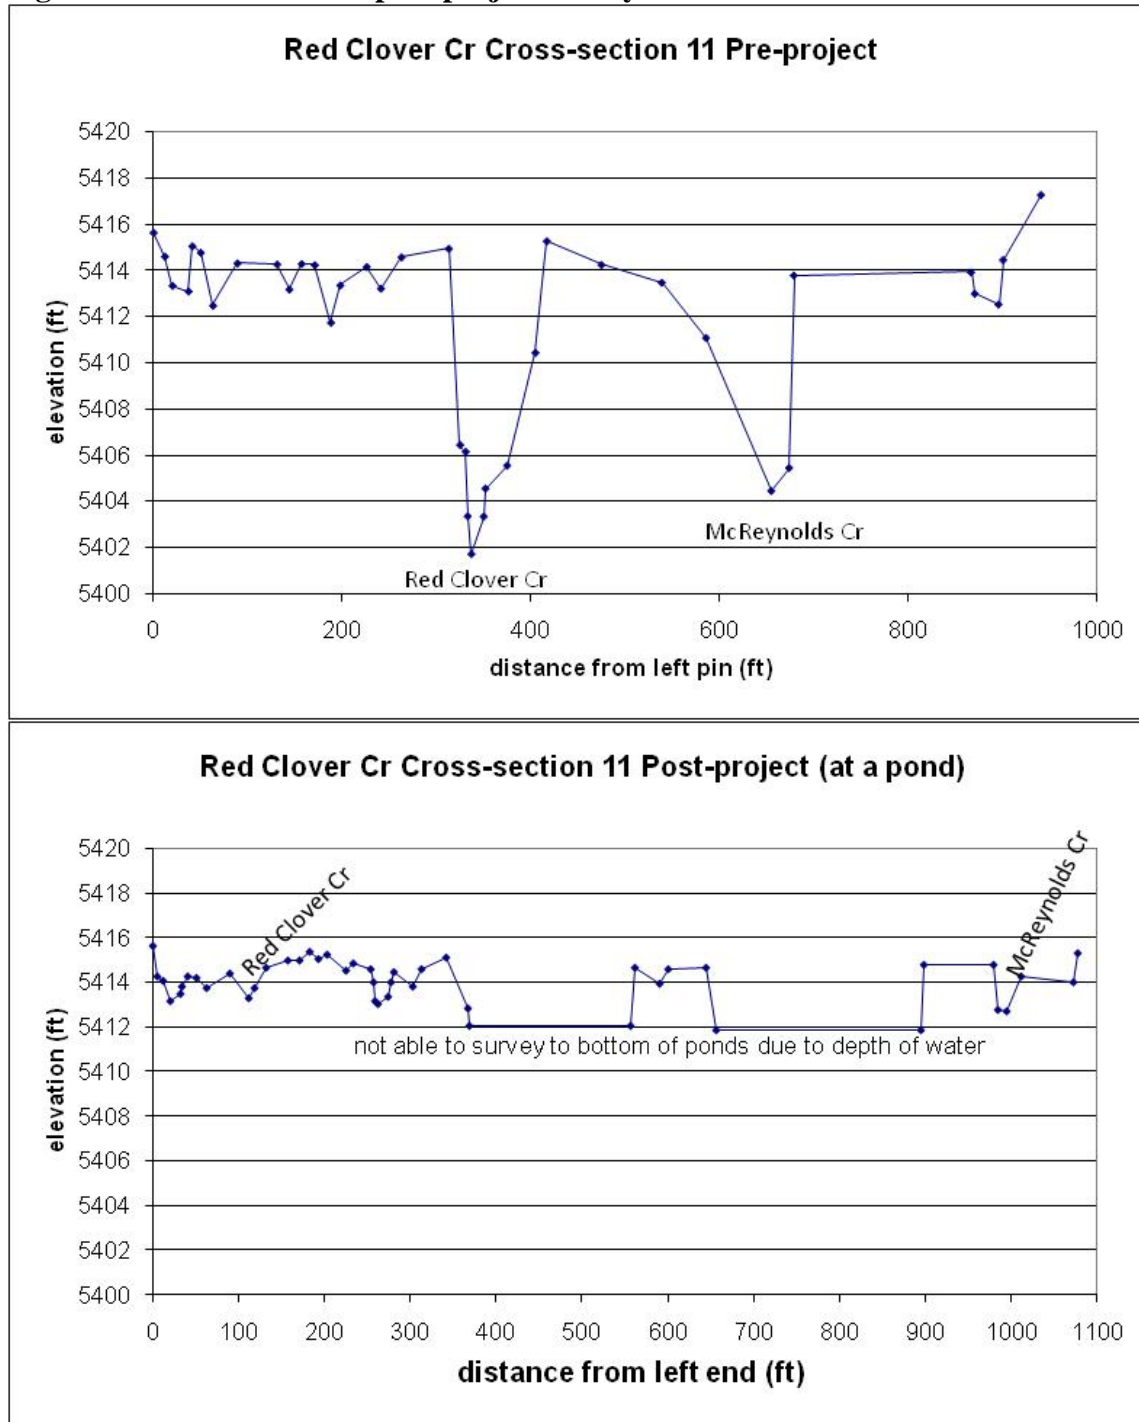
Figures 16 through 21 show pre- and post-project channels. The main channel changed from a large entrenched gully to a small channel on the surface of the meadow. Actual post-project survey data is only on cross-section 11, due to difficulty in finding end pins on the other cross-sections, however, the post-project cross-section is an accurate depiction of the post-project condition.

**Figures 16 & 17. Pre- and post-project surveys of cross-section 11.**

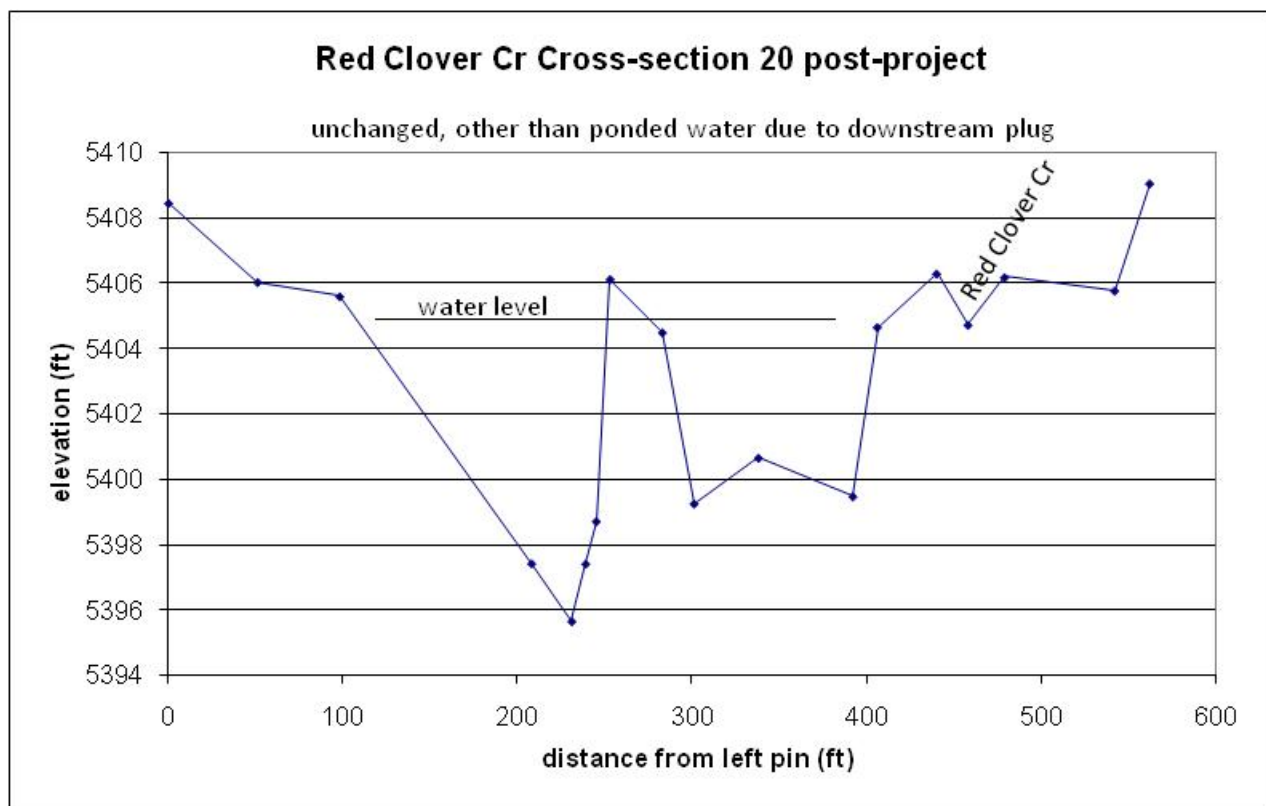
**Figures 18 & 19. Pre and post-project surveys at cross-section 20.**

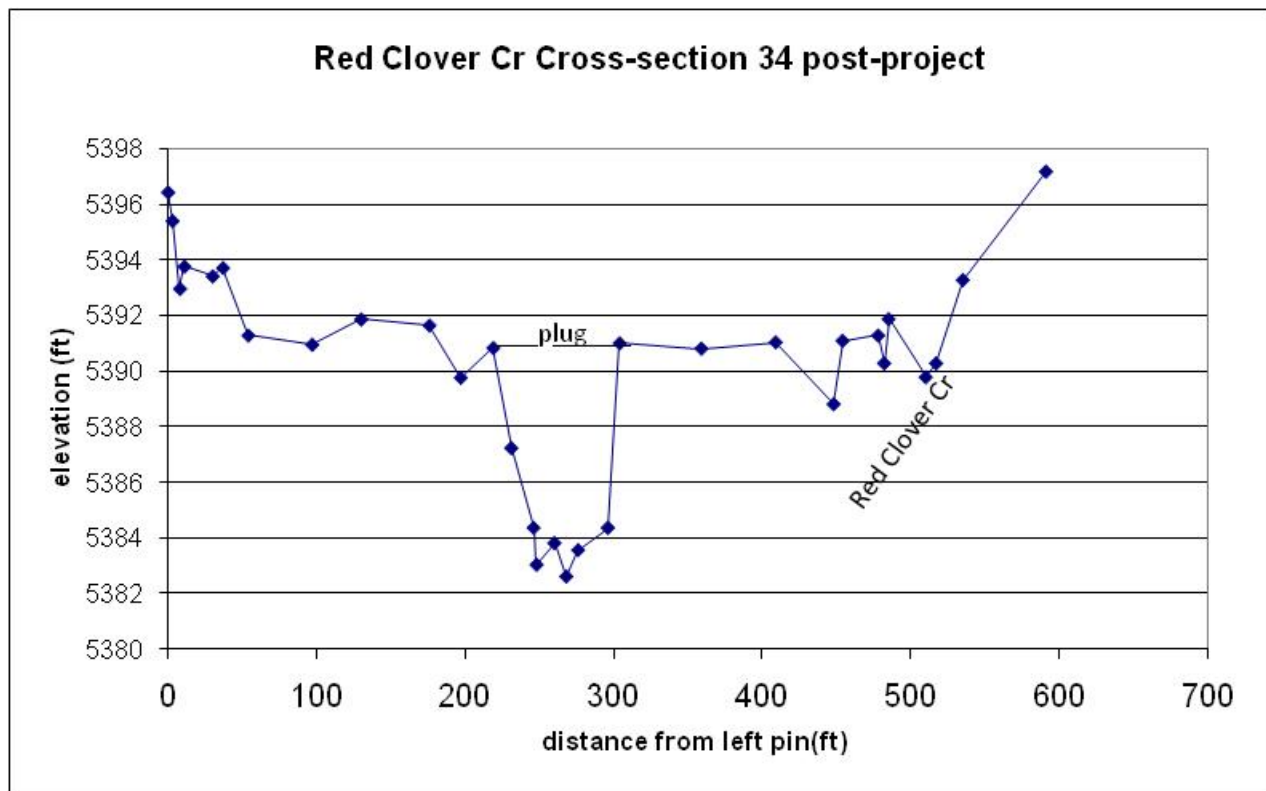
**Figures 20 & 21. Approximate pre- and post-project surveys at cross-section 34.**

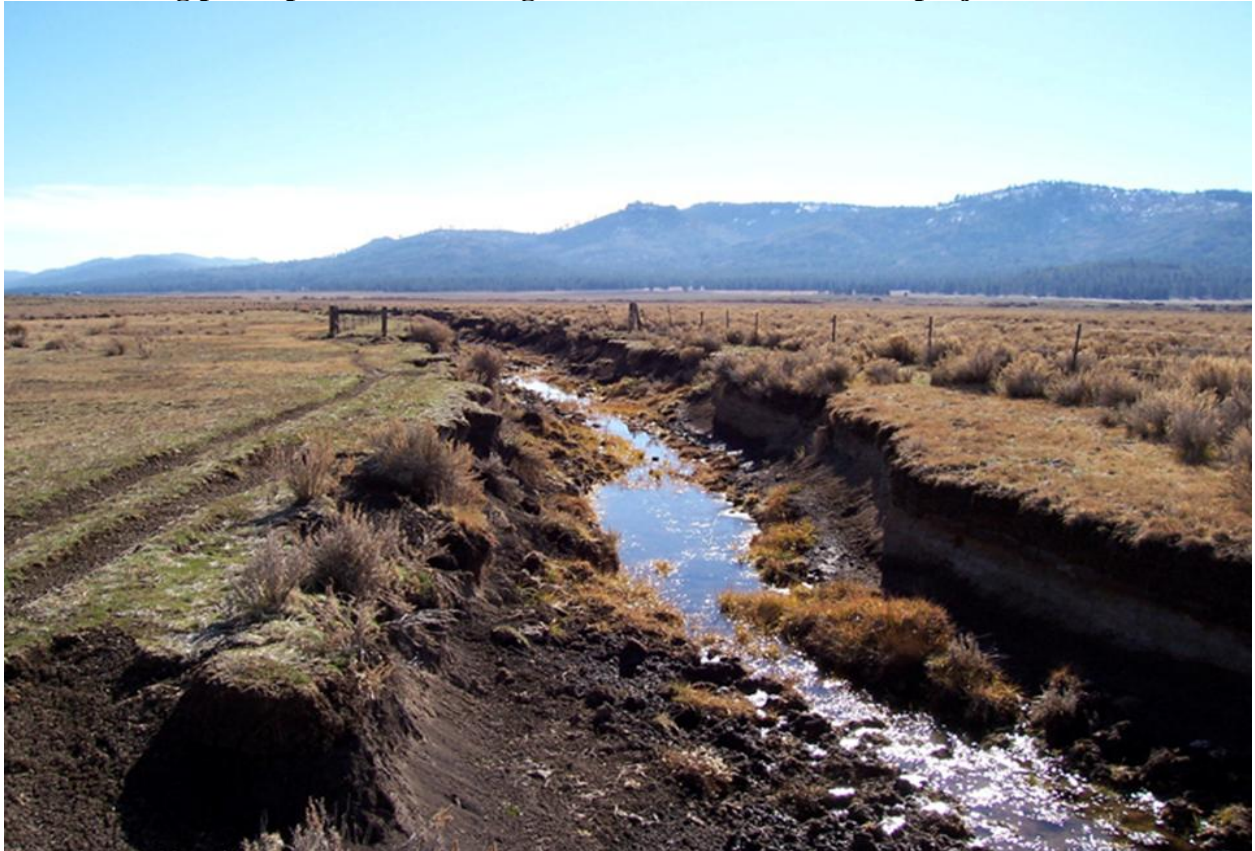
**Photo 2. McReynolds Creek gully pre-project 2004.**

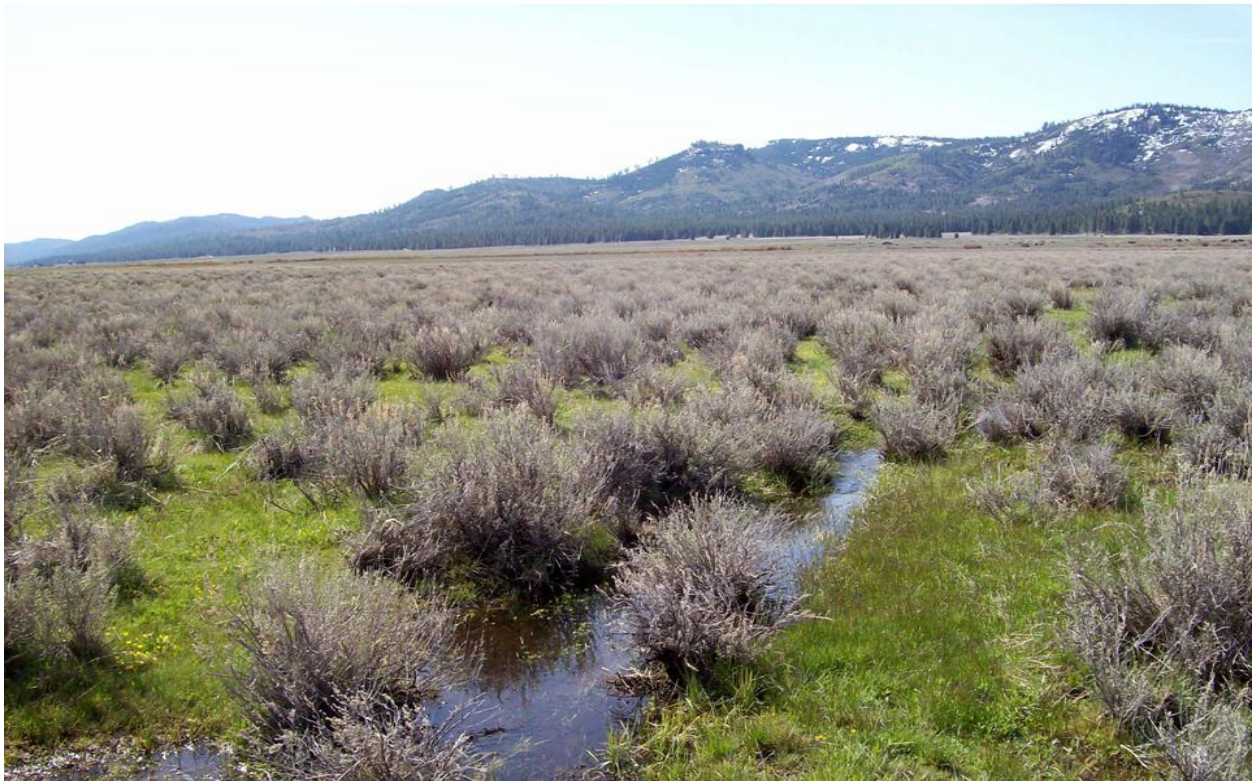
**Photo 3. McReynolds Creek remnant channel post-project 2007.**

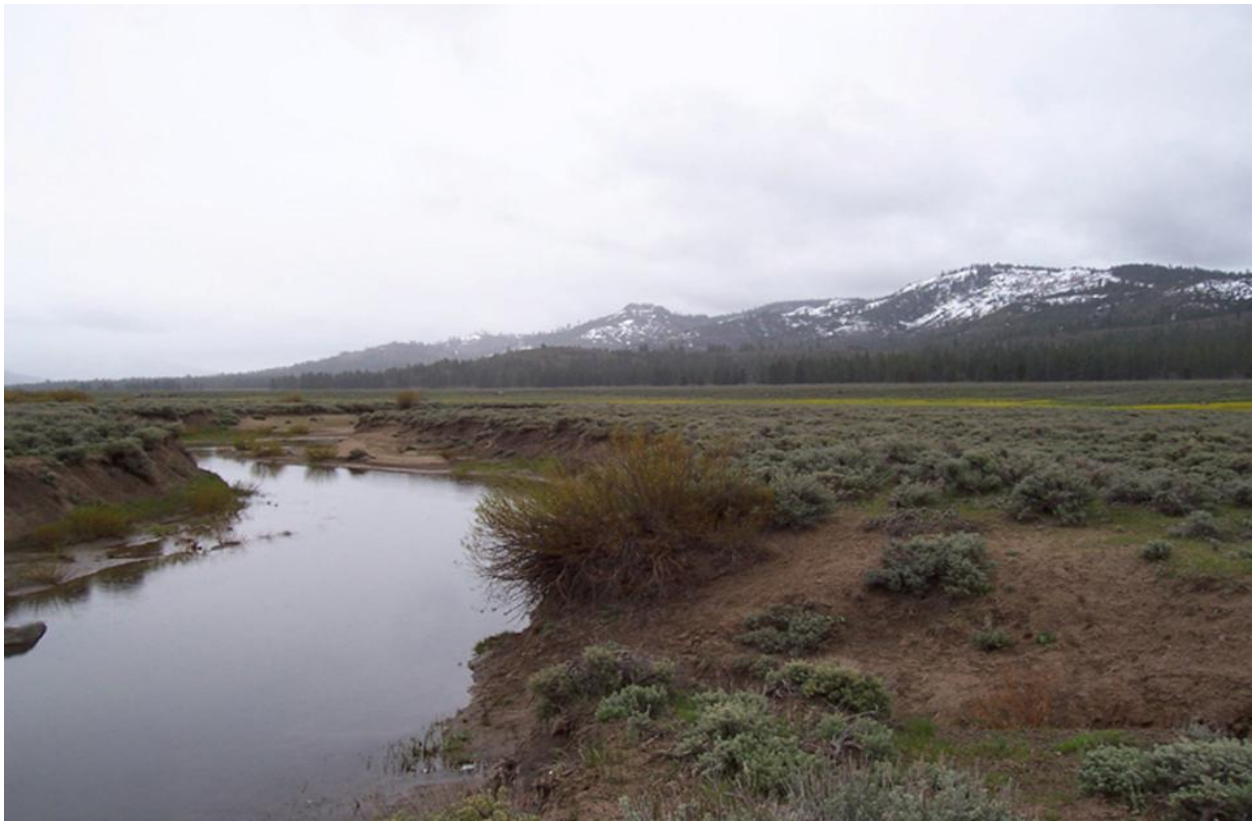
**Photo 4. Red Clover Creek gully at photo point cross-section 19 pre-project June 2006.**

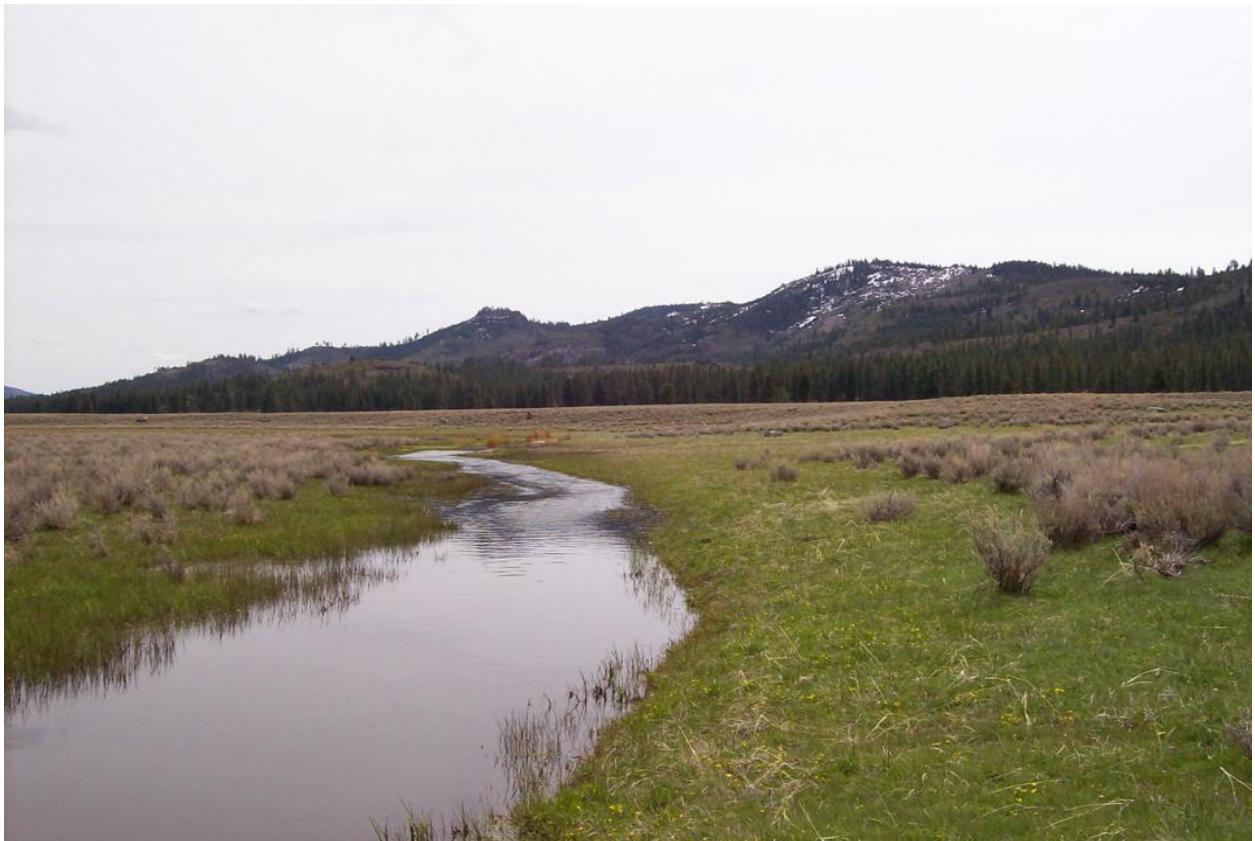
**Photo 5. Red Clover Creek remnant at photo point cross-section 19 post-project June 2007.**

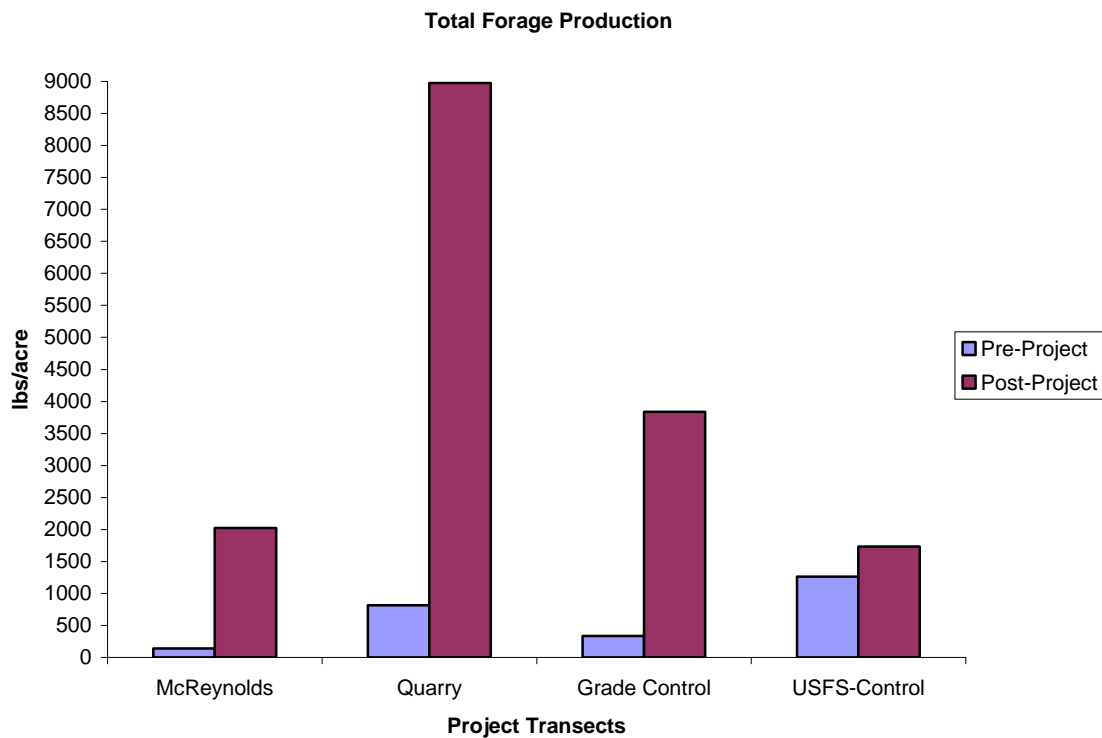
**Figures 22. Total Plant Production Pre- and Post-Project.**

Total annual production, including woody material, was estimated using USDA- NRCS plant production protocols as outlined in the *NRCS Quick Start Monitoring Manual for Grassland, Shrubland, and Savanna Ecosystems*. Sampling was conducted between mid-May and early-June pre-project (2006) and post-project (2007) on four transects, three within the project area and one control transect outside the project area. Total plant production increased on all transects in 2007, with a decrease in sage within the project area. Sage increased on the control transect downstream of the project area. Overall species composition increased at all sites, with an overall increase in the diversity of grasses and forbs on each transect. The greatest change in composition was seen along the Quarry Transect at the top of the project area along Red Clover Creek where three times as many species were noted in 2007 than in 2006. As the hydrological changes continue to influence the plant communities within the project area, it is expected that more mesic, palatable meadow species will dominate the sites, as the less desirable xeric species decline in abundance.
