Final Report

Red Clover/McReynolds Creek Restoration Project

Agreement Number 04-116-555-01

Feather River Coordinated Resource Management - Plumas Corporation

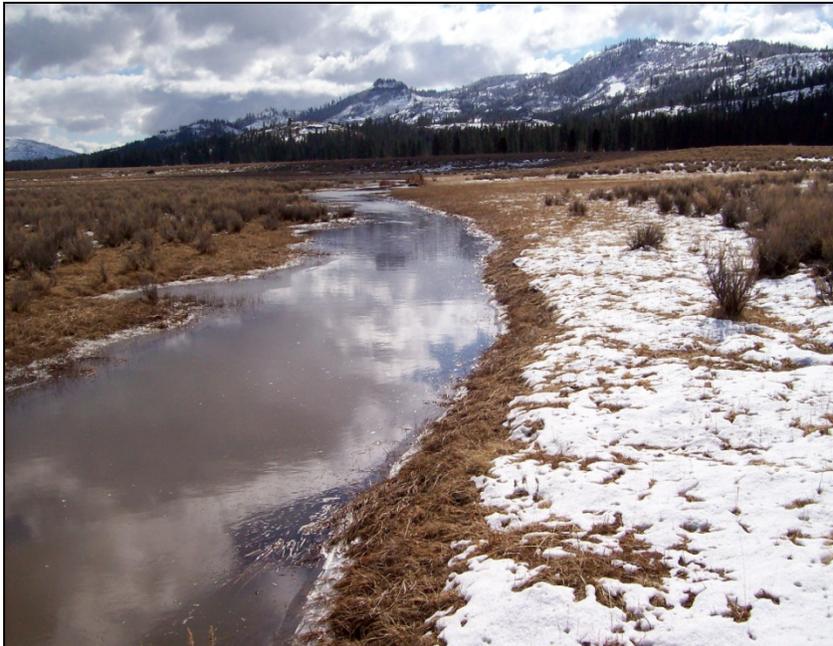
Channel after 2/13/07 flood event, snow line is high water mark

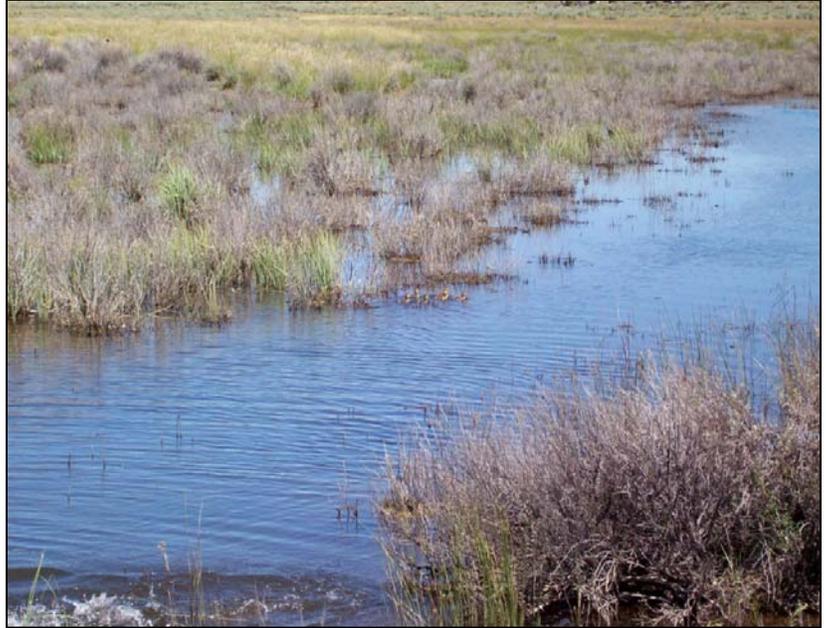
**Vegetation changes 7/2/07,
sage is rapidly dying.**

The increase in perennial grasses and forbs is well documented in the Monitoring Final Report. To summarize here, all project areas measured increased total biomass weights between 1750 lbs. and 8200 lbs. per acre, while the control also increased by 300 lbs. per acre. Sagebrush, which had encroached on the de-watered meadow, began dying back rapidly.

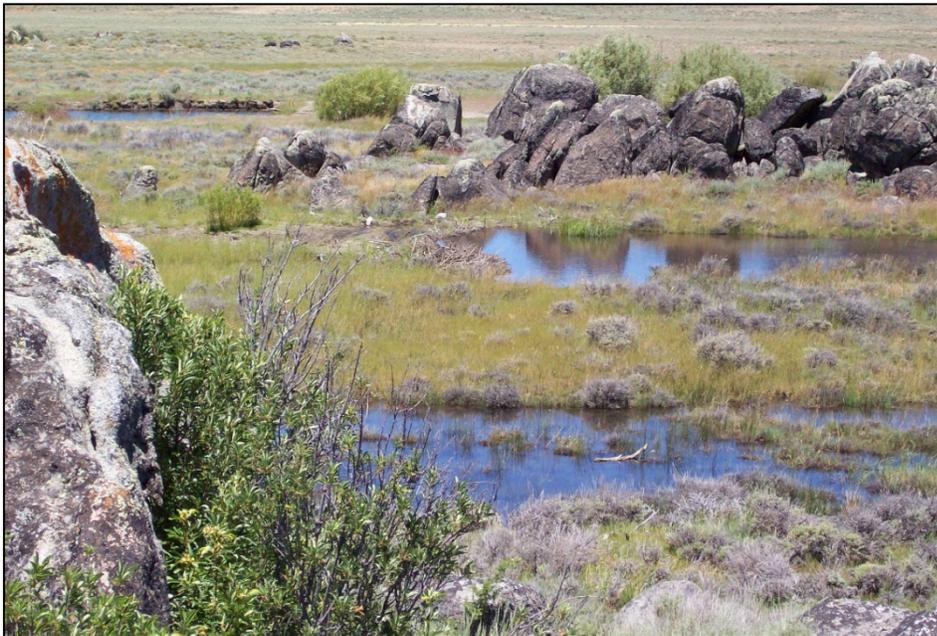
Beaver dam @ X-section 15, secondary channel in foreground now carrying flow

Beaver colonies were present up- and downstream of the project area prior to construction. The primary design

measures incorporated for the beaver were: 1) to increase the frequency of plugs to minimize the elevation differences; 2) to maintain connectivity of all remnant channels across the valley surface. These measures would accommodate the potential for the beaver to disperse water across the valley with their dams. The beaver moved into finished portions of the project before it was completed. In the first year post-project, over twenty beaver dams have been built in the project area. The measures incorporated are working as designed and the beaver are augmenting the project objectives, not putting them at risk.

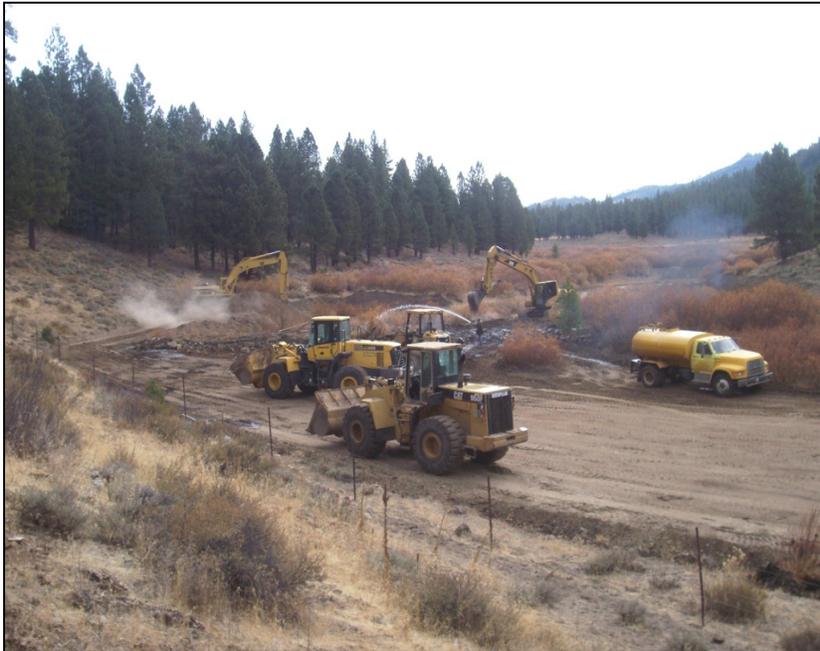
Work on the rock constriction plug. Rarely was all equipment in one photo frame.

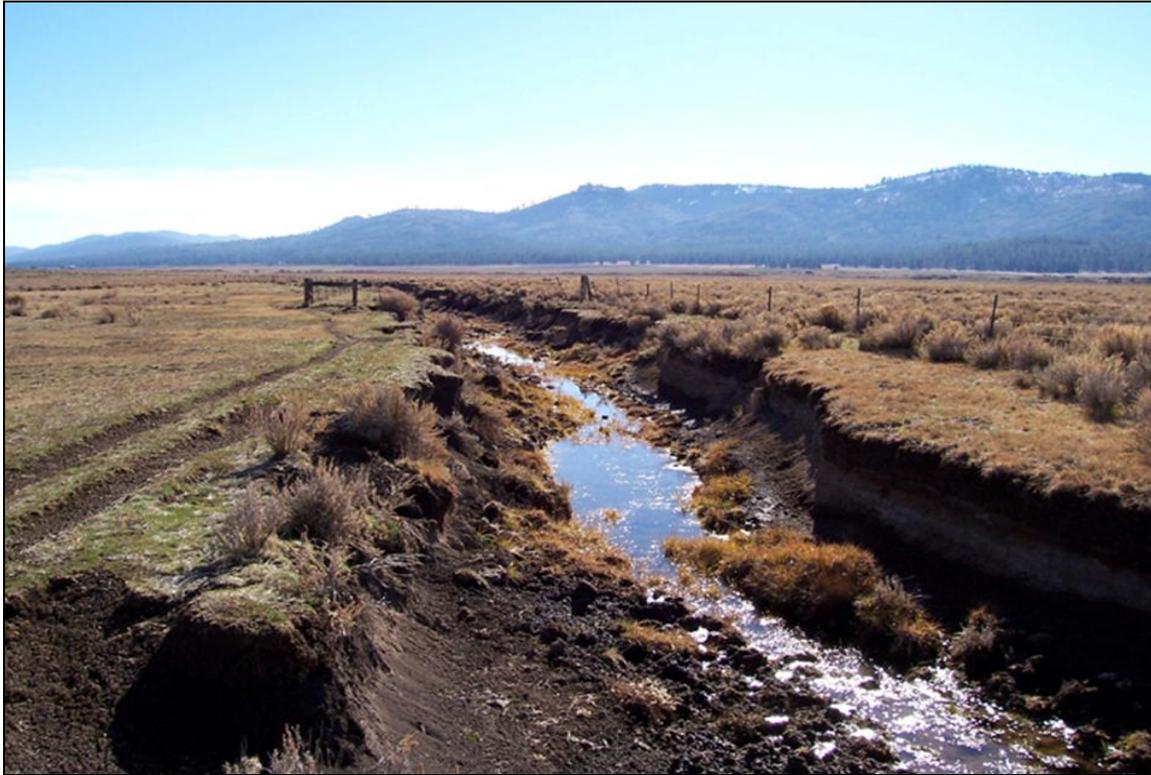
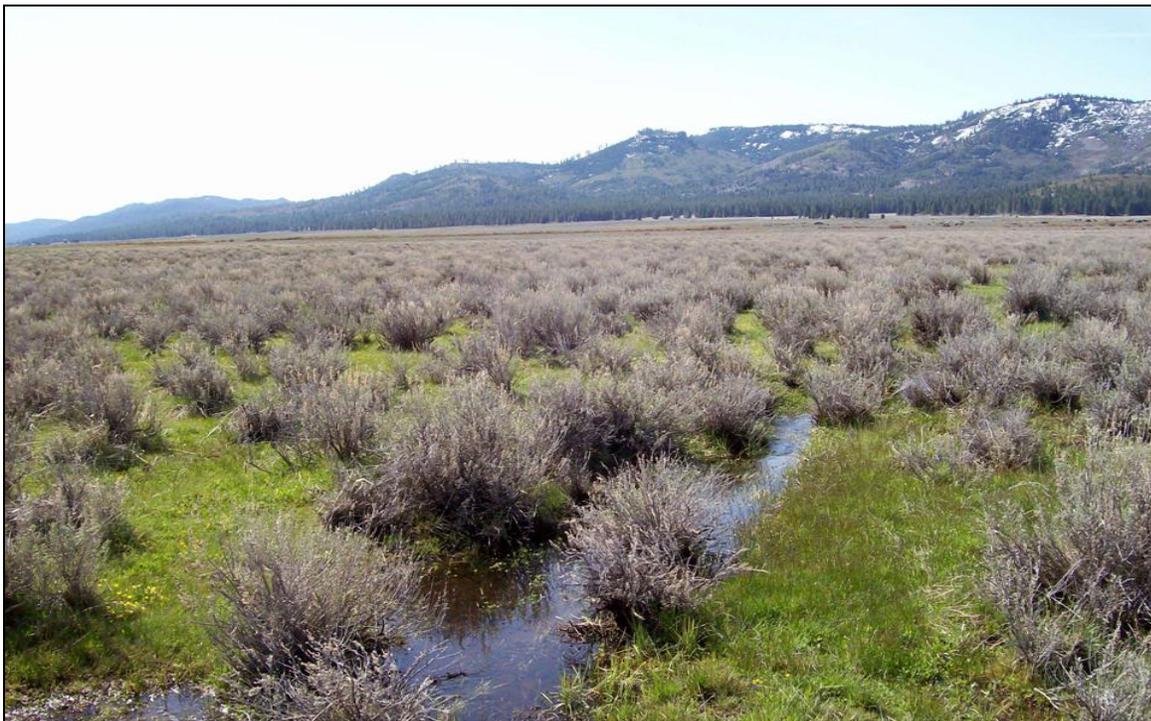
McReynolds Creek pre-project, 2004 above; post-project, 2007 below

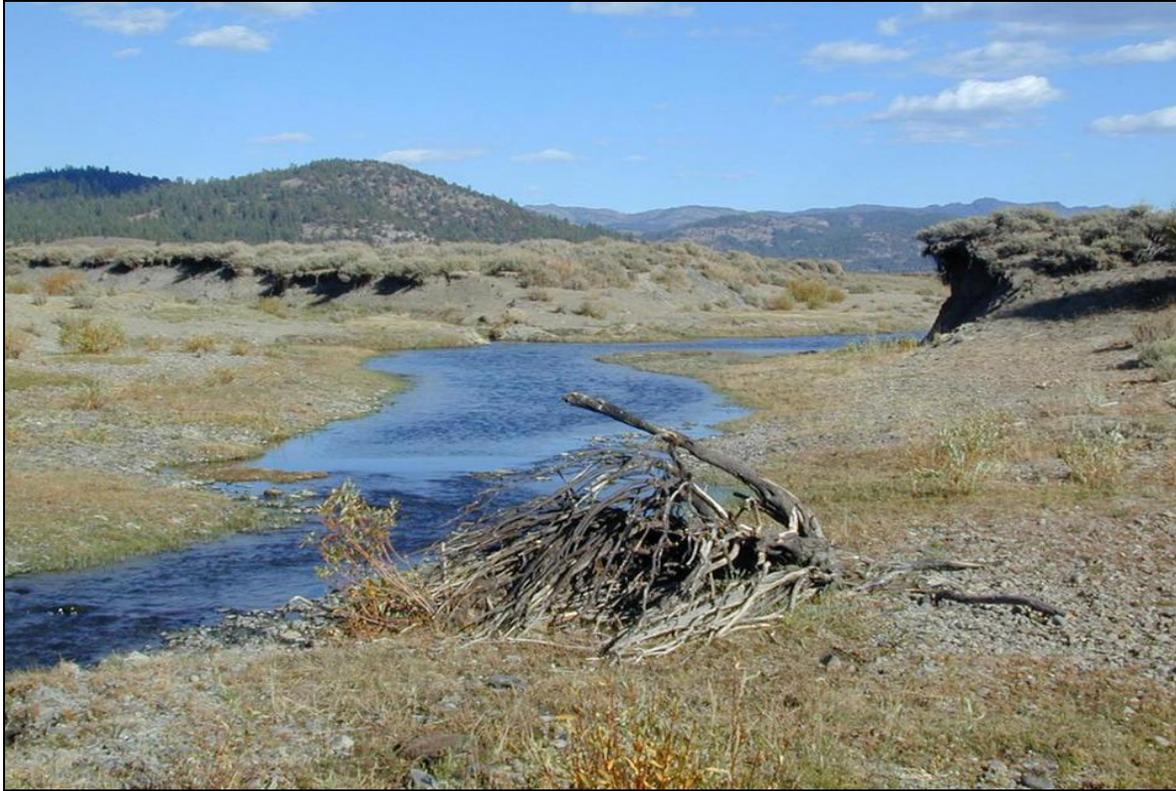
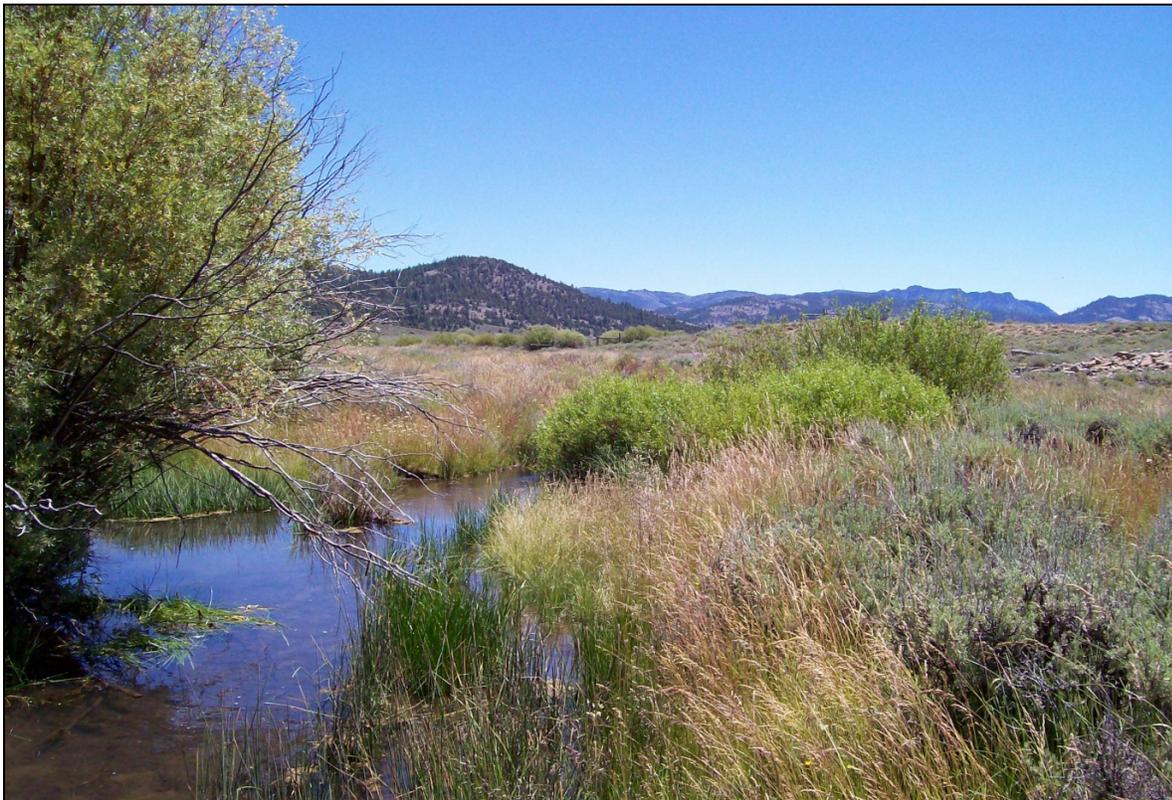
Confluence McReynolds/Red Clover Creeks pre-project, 7/2004 above; post-project, 7/2007 below

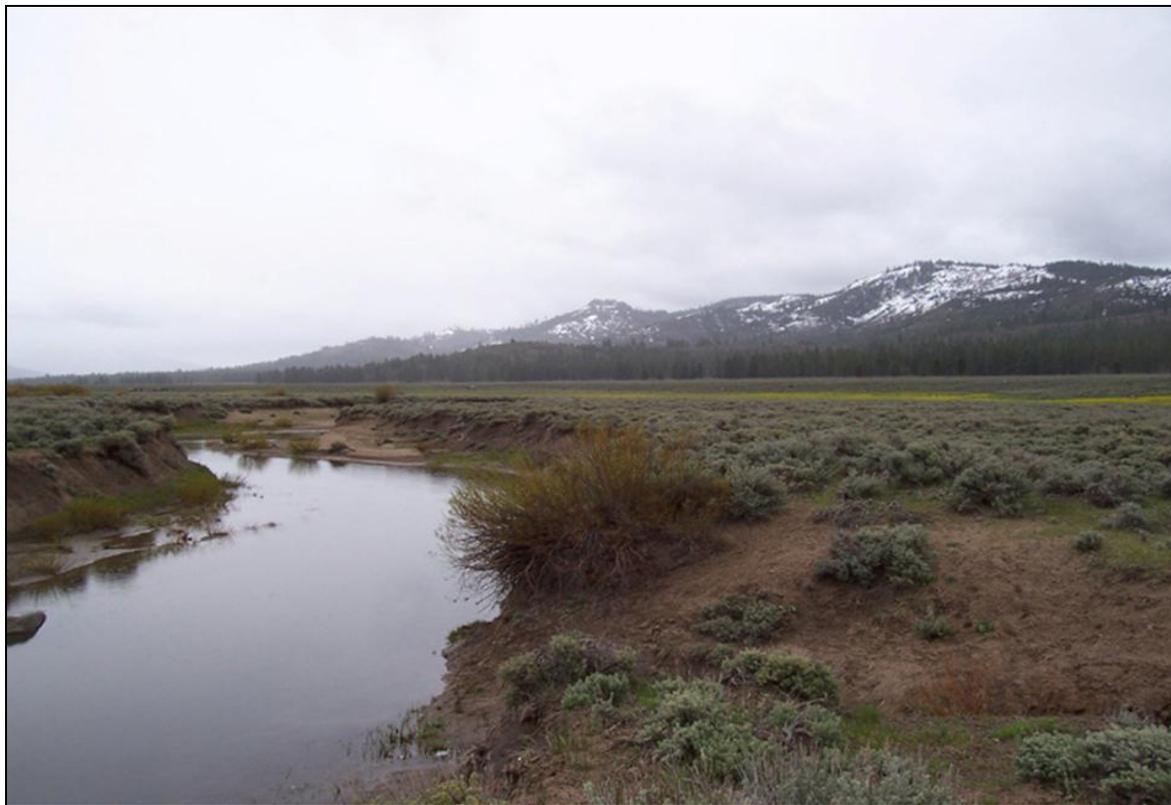
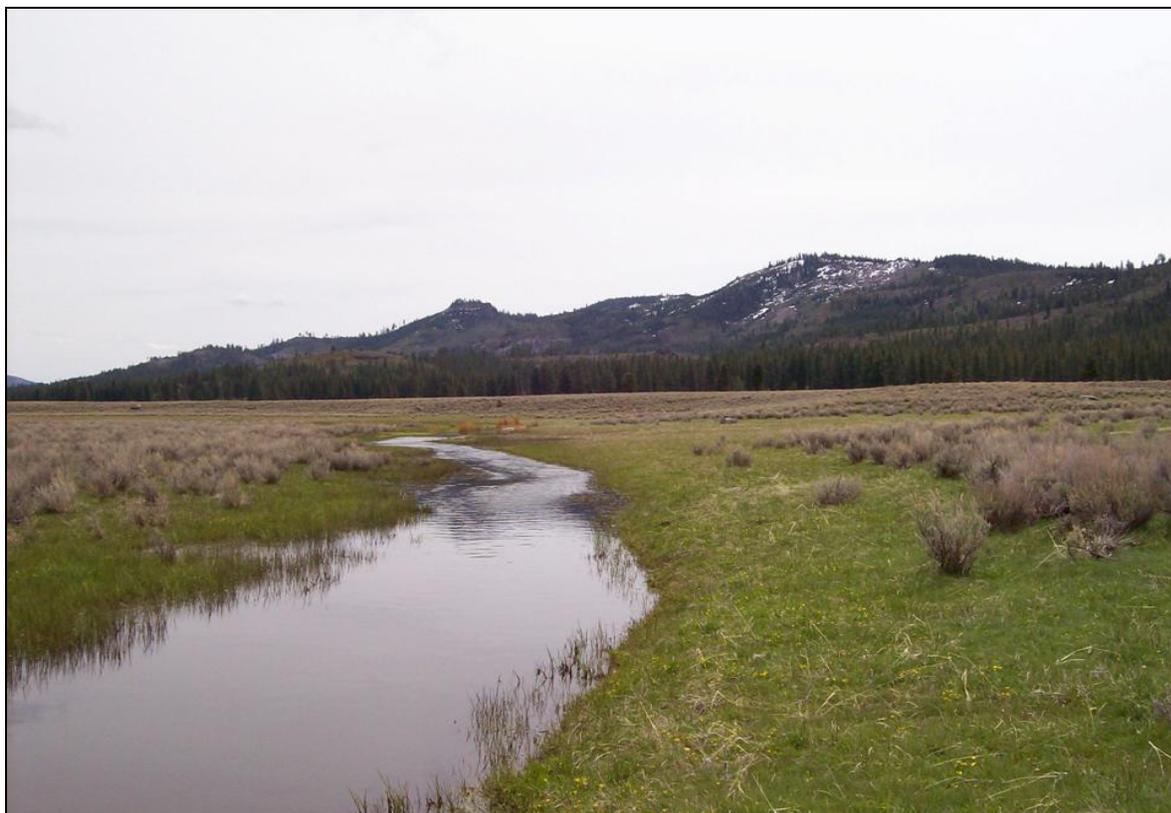
Red Clover Creek @ X-section #19 pre-project, 6/2006 above; post-project, 6/2007 below

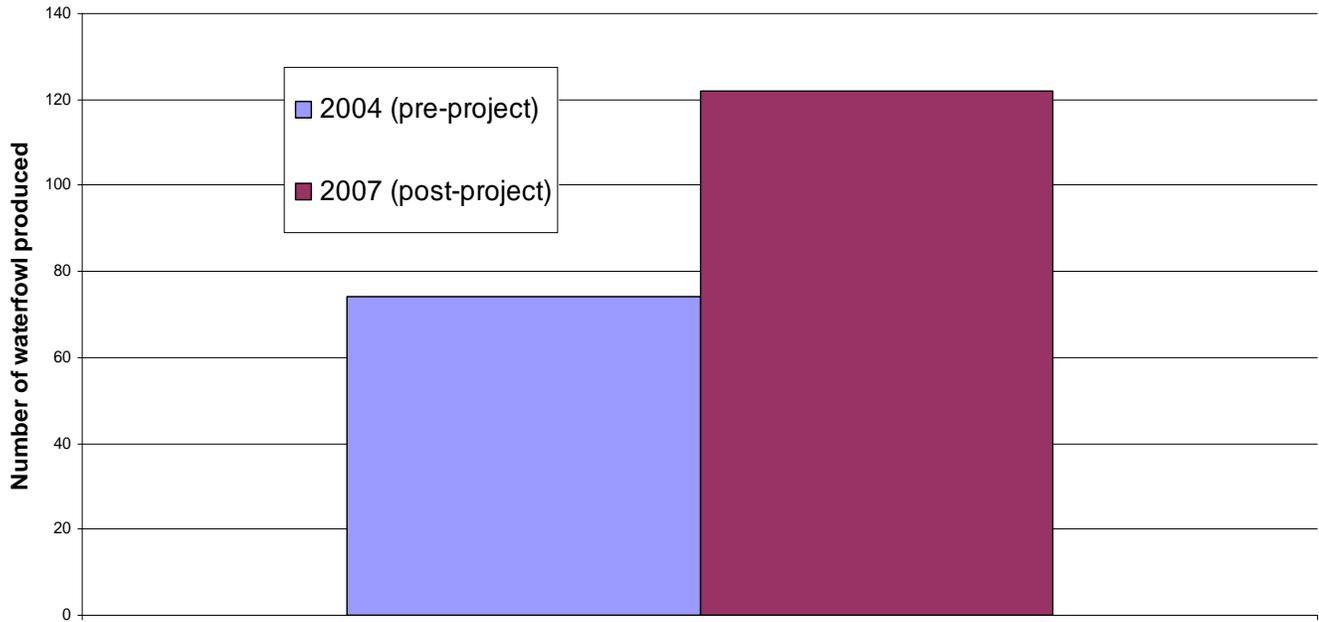
Red Clover/McReynolds Creek Project Annual waterfowl production

Nine waterfowl species were observed pre-project, with three species breeding; mallard, green-winged teal and common merganser. Eighteen species were present post-project with eight species breeding; bufflehead, gadwall, green-winged teal, blue-winged teal, mallard, Canada goose, common merganser and pied-billed grebe. Sandhill cranes were
