**PRELIMINARY ASSESSMENT**

**THE COLD STREAM WATERSHED**

**A tributary of the Little Truckee River**

**Sierra County, California**

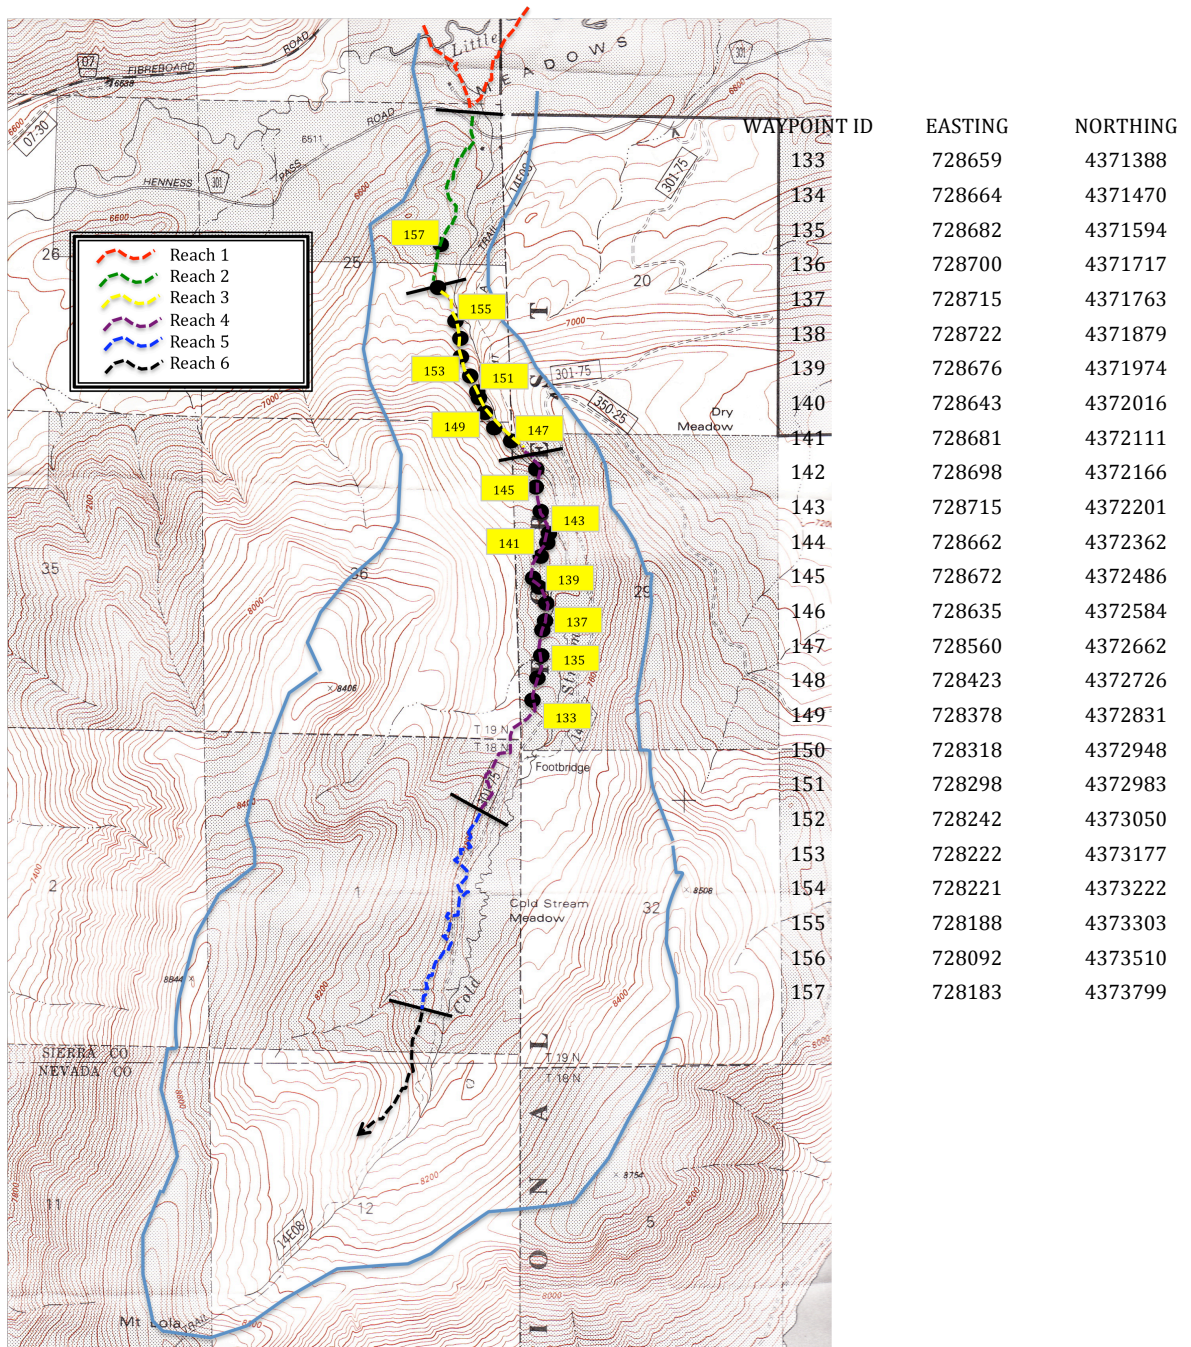
Figure 1: Map of Stream Reaches with video waypoints (UTM).

Reaches 3 and 4 are the least accessible sections of the main channel owing to terrain and distance from the main road. On August 31, 2010, this section was traversed on foot while capturing video segments of representative sites along the way. These sites are referenced to GPS waypoints shown on the following map (Figure 1). Narration on the video clips identifies the waypoint identifier. The video is included on CD-R as a supplement to this report with the intent of giving the reader of this report a visual sense of this stream section. Reach 3 with its unstable hillsides and potential vertical and flow-velocity barriers to upstream fish migration is possibly the most critical reach from a fish habitat perspective.
