PHOTOS DEPICTING ALLUVIAL FAN REACH OF COLD STREAM. Notice numerous wetted channels (distributaries) apparent on aerial view (TOP LEFT)

PHOTOS DEPICTING COLD STREAM MEADOW REACH

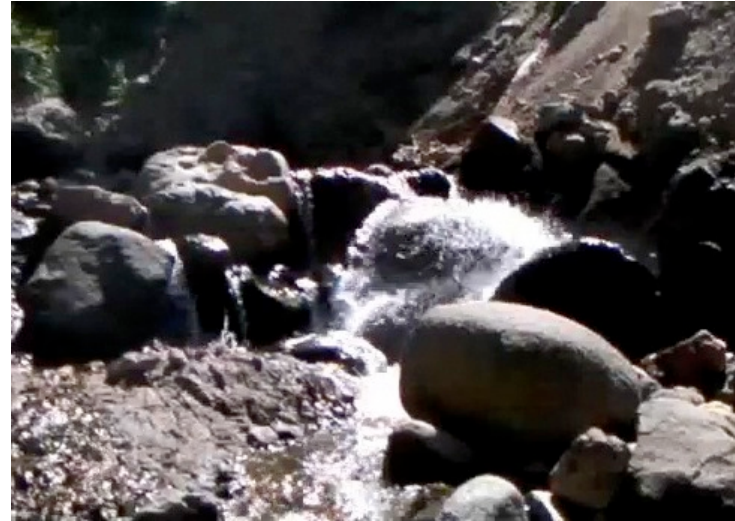
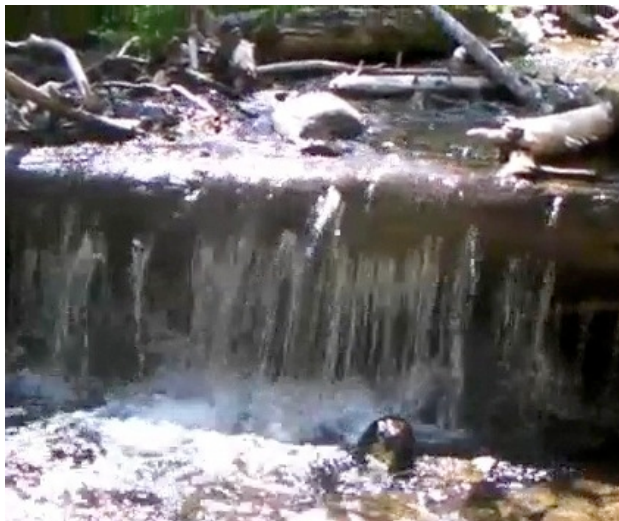
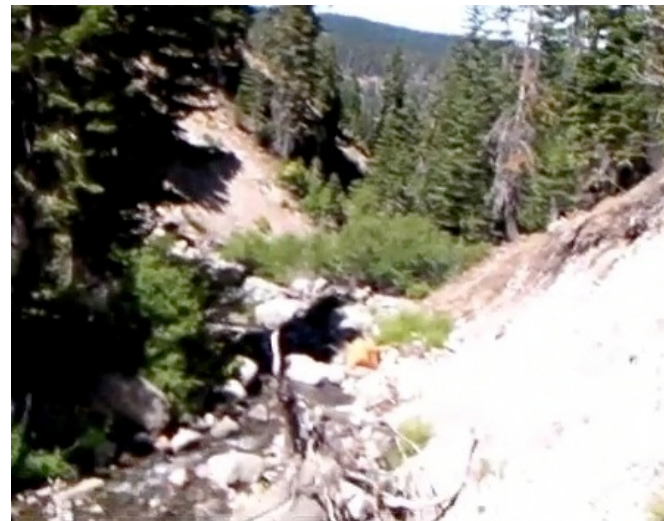
TOP/BOTTOM LEFT highlights the role of log steps in pool formation and bedload retention in the high gradient reach. TOP RIGHT: Bedrock chute through reach 3. BOTTOM RIGHT: Landslides flanking channel in reach 3

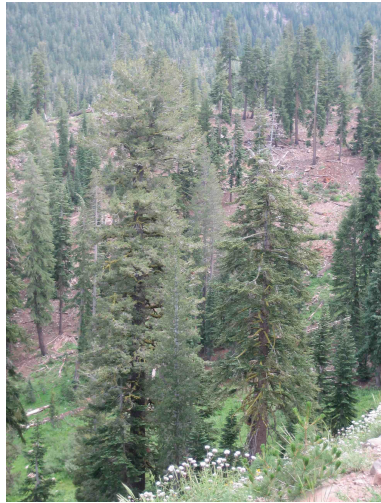
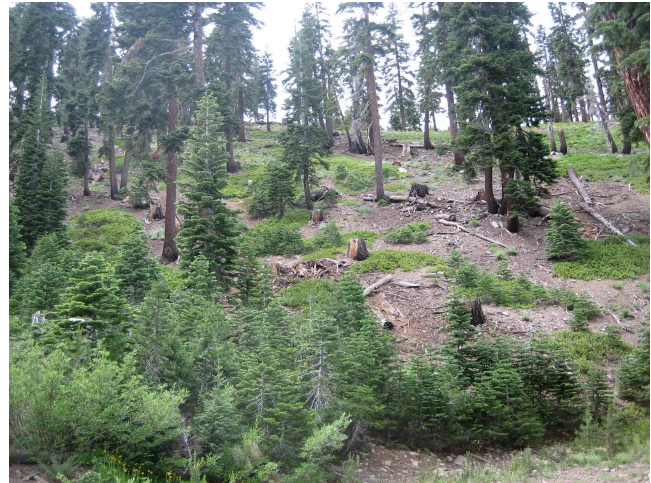
TOP ROW: Views of logged areas in Section 1, T16N, R14E. BOTTOM LEFT shows hard road surface resisting surface erosion from upslope. BOTTOM RIGHT shows a small drainage problem on spur road.

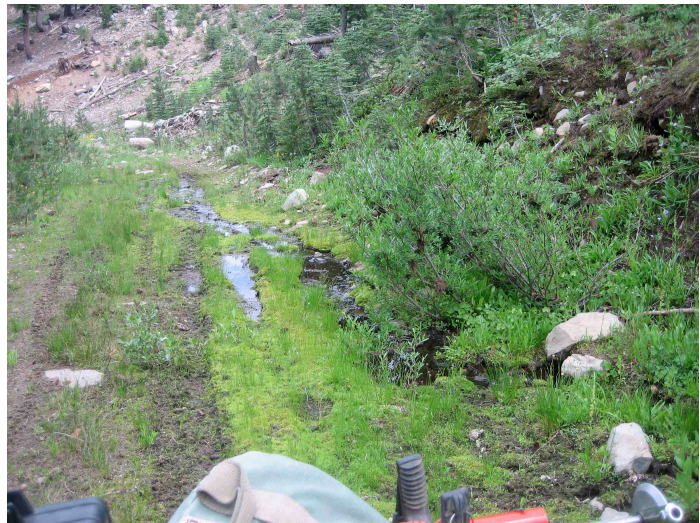
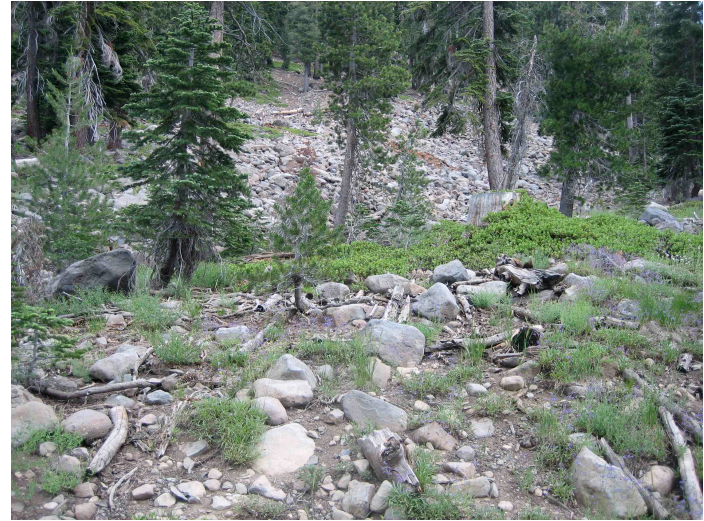
TOP LEFT is aerial view showing numerous springs in upper basin. TOP RIGHT shows accumulation of glacial drift in reach 4. BOTTOM LEFT: Granite "erratic" boulders. BOTTOM RIGHT: Volcanic outcrop with talus slope below
