# Feather River Coordinated Resource Management Watershed Monitoring Program

## 2006 Report

Prepared by Plumas Corporation  
Quincy, CA  
Spring 2007

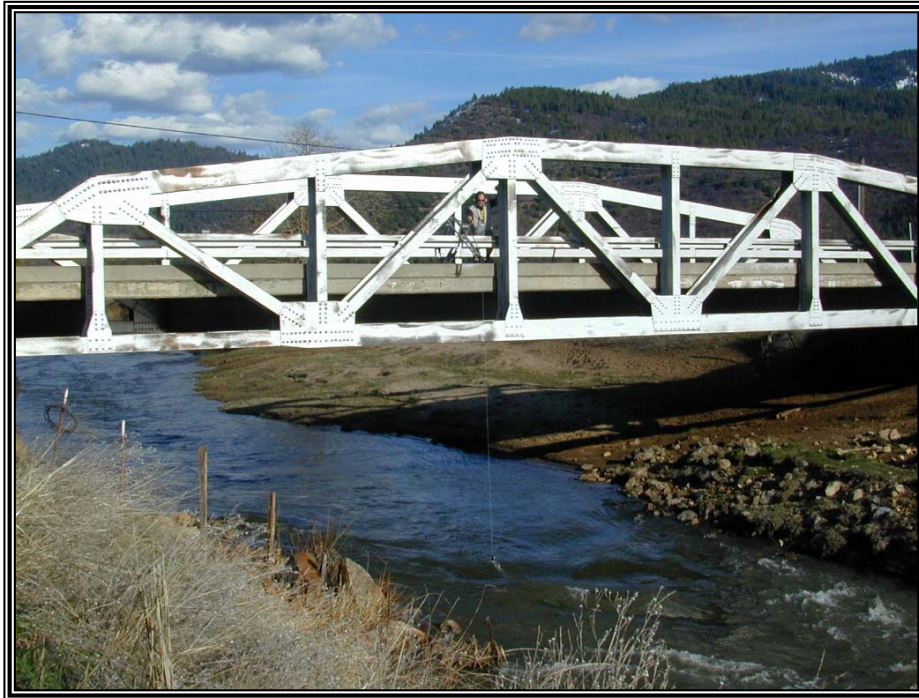
Recording flow using a bridge crane from Deadfall Bridge on Lights Creek, Indian Valley

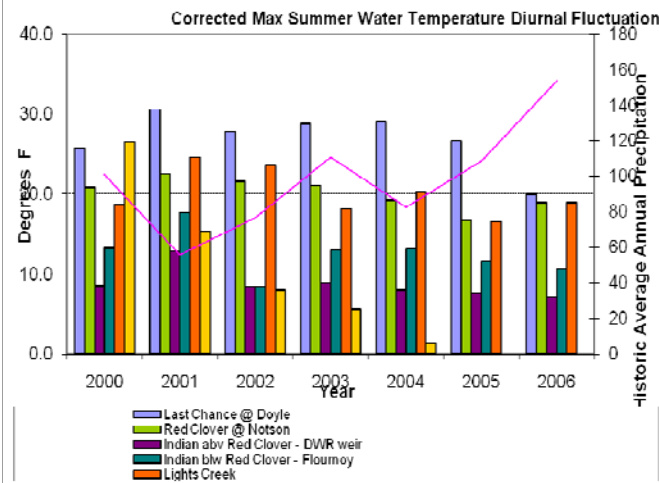
Figure 21. Maximum summer water temperature diurnal fluctuation recorded from 2000-06

Figure 21 displays the greatest fluctuation in temperature in a 24-hour period during the sampling period. Since this parameter is heavily dependent on the volume of water and elevation, a comparison between years at the same site is most appropriate. Last Chance at Doyle Crossing exhibits a significant downward trend in diurnal fluctuation of maximum summer water temperature from 2004-06. Over the entire six year record, Wolf Creek portrays the most obvious decreasing trend in maximum water temperature diurnal fluctuation during the summer. Such a change could be due to a combination of factors such as increased riparian vegetation, CRM's restoration projects upstream of the gage, and beaver dams increasing
