TECHNICAL REPORT #1

January, 22, 2010

Big Meadows Restoration Project, October 14, 2009 Flood Event

Feather River Coordinated Resource Management, Plumas Corporation

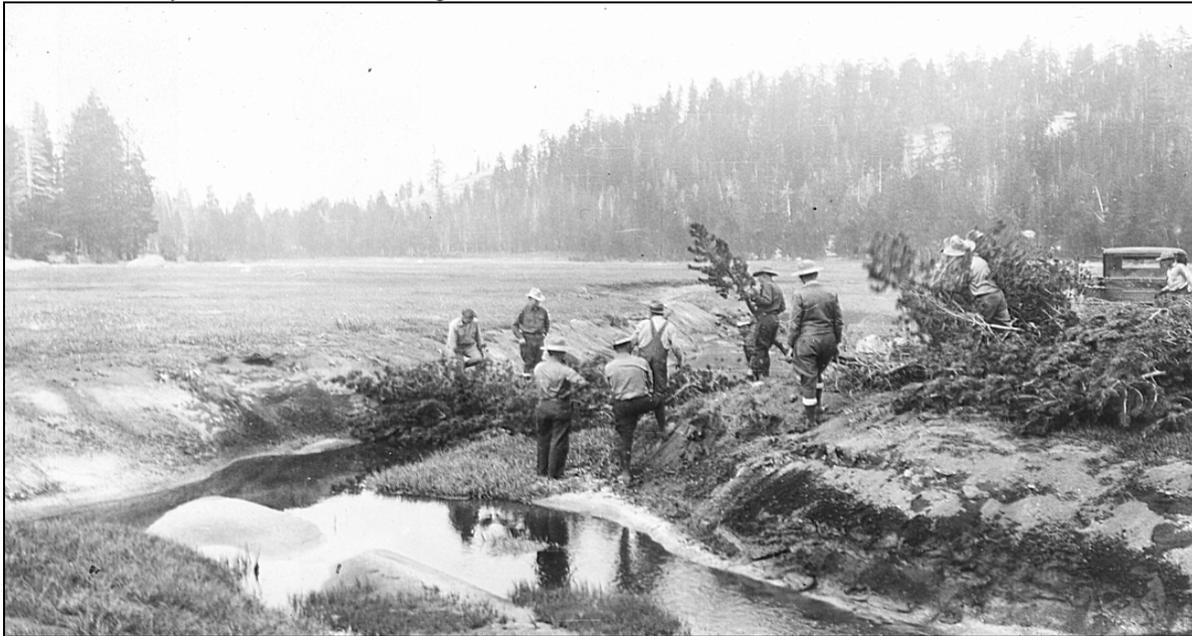
Photo #1. brushdams, circa. 1934 (Note: similar meadow location as photo series 7b & 7e) USFS Archives

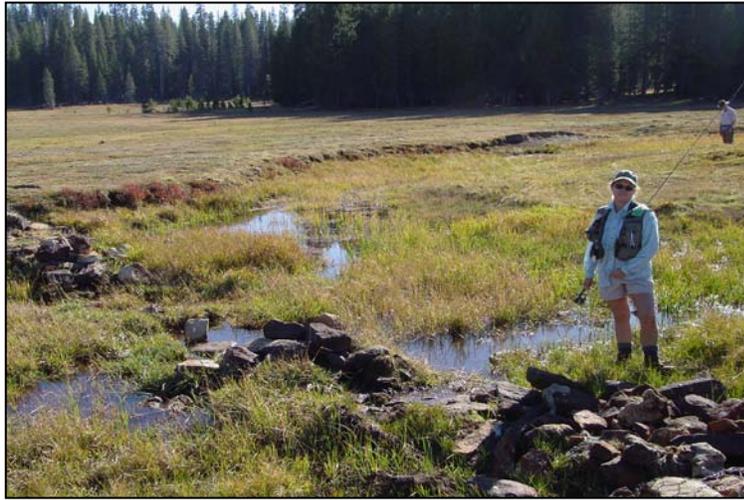
Photo #2. Gabion checkdams

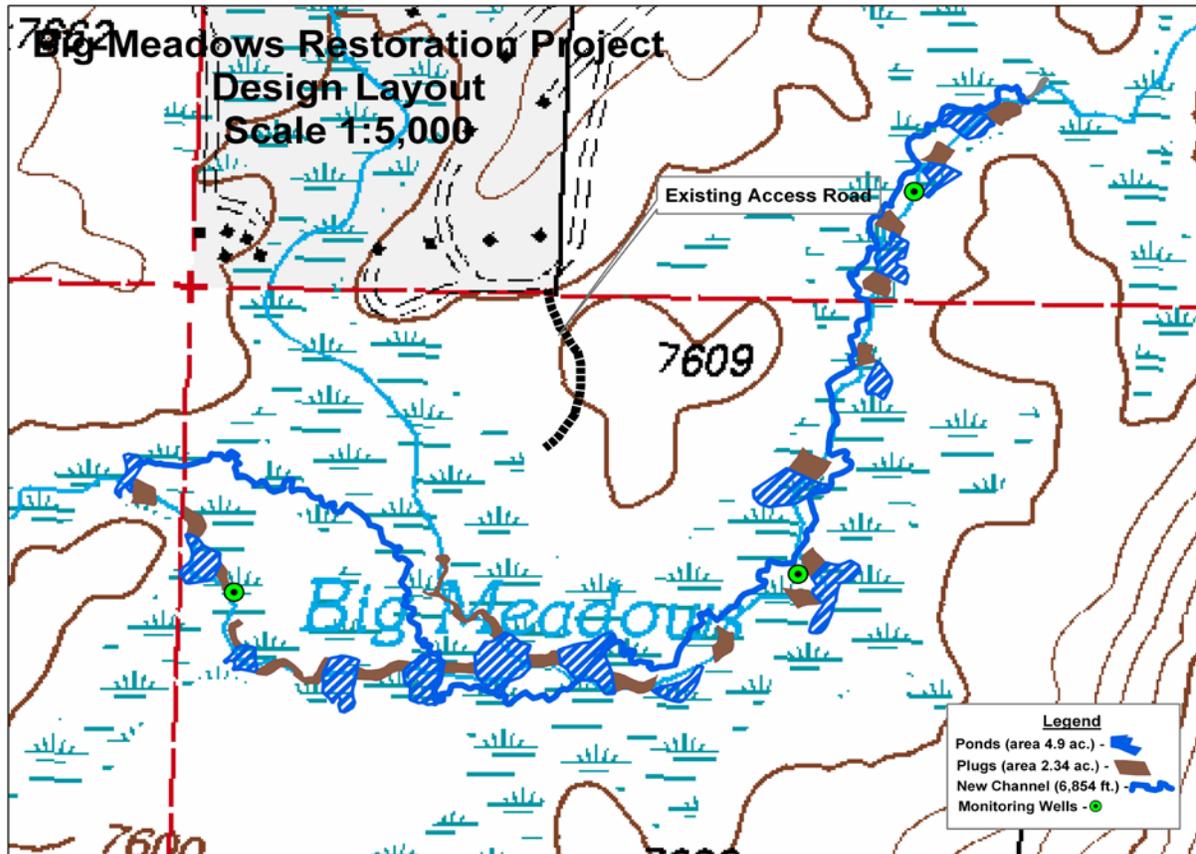
Map #1. Big Meadows Project as-built restoration design.

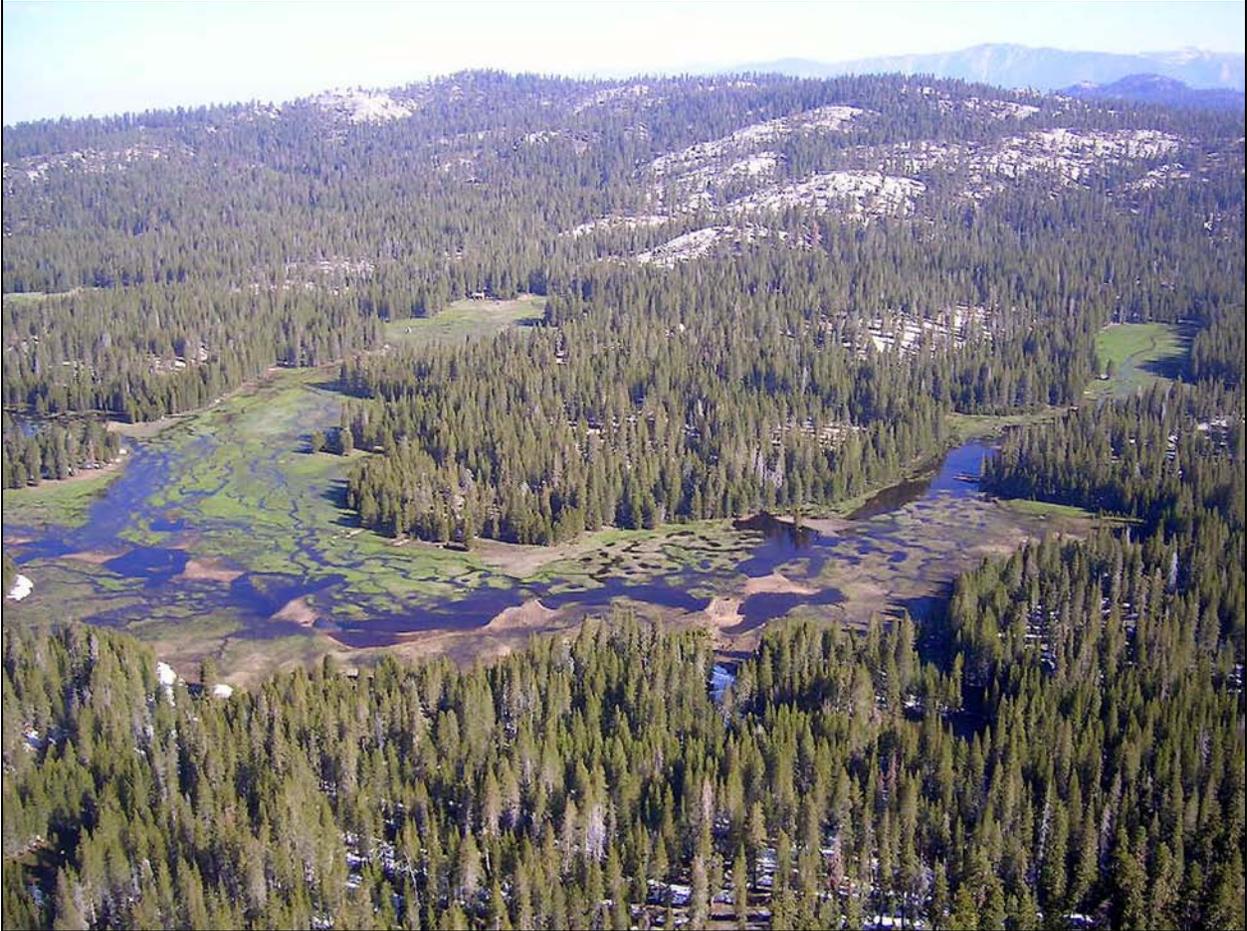
Photo #3. Big Meadows post project- spring, 2008 (streamflow is left to right). Photo by: Wayne Luallen

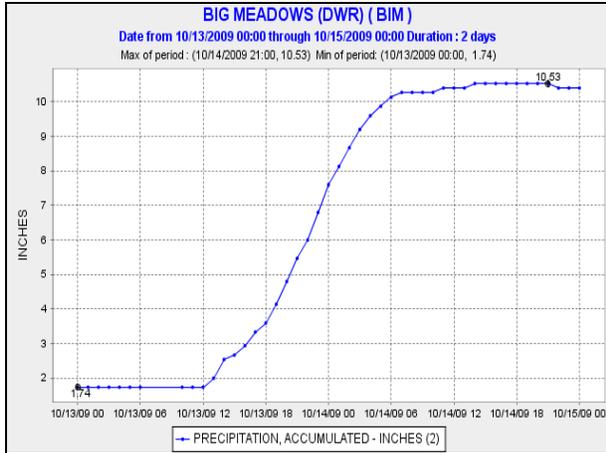
Fig. 1

The Big Meadows Restoration Project was subjected to a high volume, high intensity rainfall event on October 13-14, 2009. Between 1200 hours, Oct. 13 and 0700 hours, Oct. 14, 8.27” of rain fell in the Big Meadows area. This measurement was recorded by the Big Meadows RAWS (Remote Automated Weather Station, Figure #1), located in the meadow. Between 1800 hours/Oct. 13 and 0300 hours/Oct. 14, rainfall rates averaged 0.62 inches/hr. with a sustained two-hour rate of 0.8 inches/hr. There was no snow in the basin and there was no antecedent moisture. This was a meso-scale rainfall event extending over much of the Kings River watershed and portions of the Kaweah basin. Post-event field observations and stream gage records from the Kings River watershed indicate that a high discharge, flash flood-type event occurred in the project and surrounding area. Figure #2 shows that plotted rainfall in the North

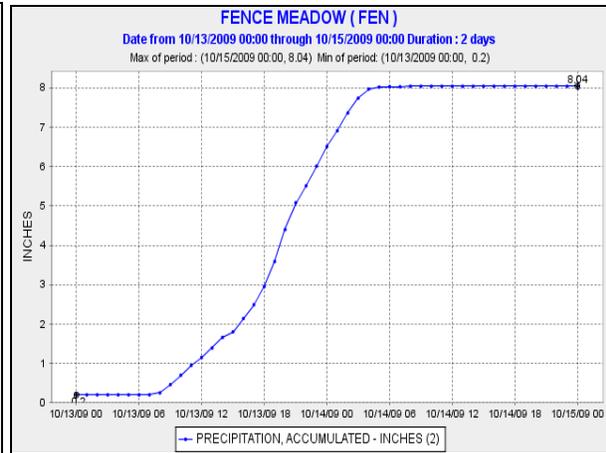
Fig. 2

Fork Kings River watershed was very similar to what occurred in the project watershed. Figures #3 & 4 are stream gage records from the mainstem Kings River and North Fork Kings River, respectively, showing high peak flows from this storm.

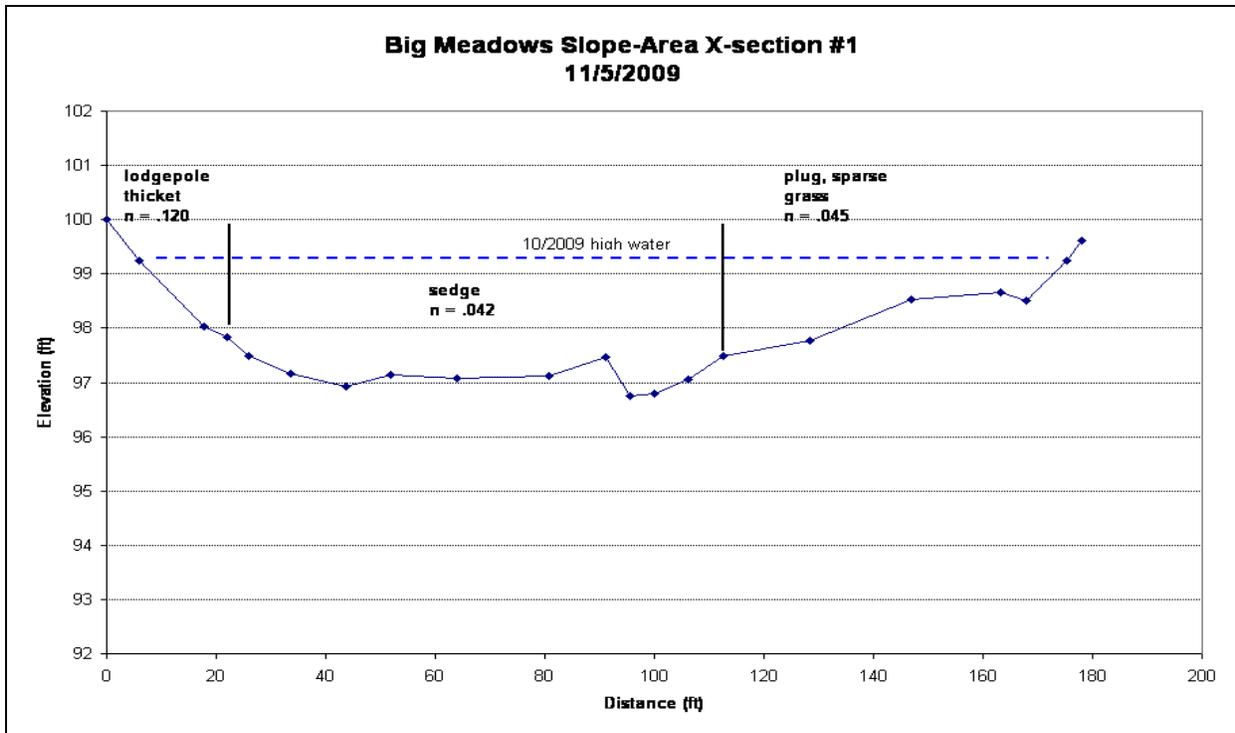
Figure 5.

Water surface slope measured as the slope of the peak flow indicators, was 1% at both cross-section locations. Discharges were calculated for individual cells with like roughness values. Three (3) cells were identified across the relatively uniform cross-section #1 (Fig. 5). Cross-section #2 was divided into five (5) cells (Fig.6). Total discharge calculated at cross-section #1 was 1242 cubic feet per second (cfs), and cross-section #2 was 1282 cfs.

Cross-section #1 contained debris deposited at the left high water level and duff scour for the right. Cross-section #2 exhibited duff/soil scour down to conifer roots for the left high water level and debris deposition on the right.

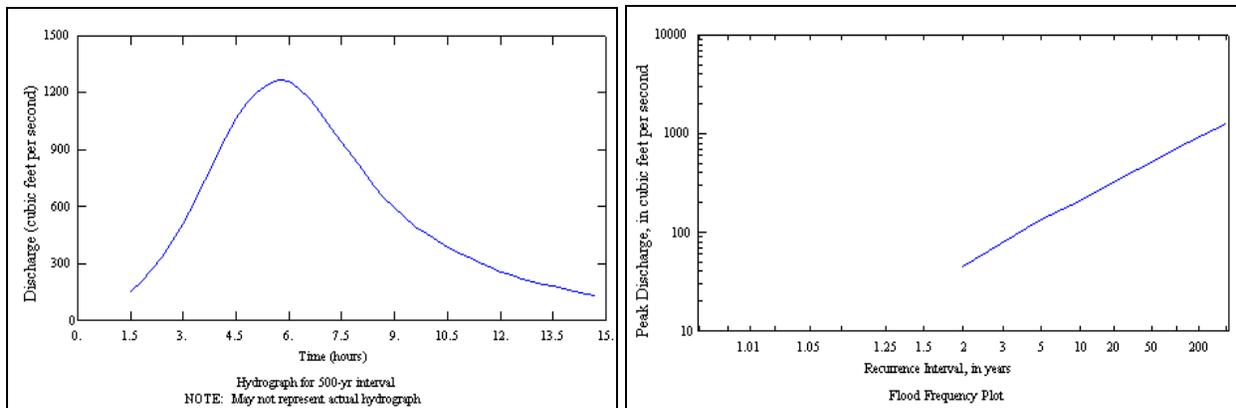
A flood frequency determination (Fig. 7a & 7b) was developed using the National Stream Statistics program (2009) available from United States Geological Survey (USGS). These data placed the October 13-14, 2009 flood event in the 500-year return interval category, with a 0.2% chance occurrence (Table #1). However, it is the author's professional judgment that, given the dry moisture condition and lack of a snowpack, this event is more likely between a 100 to 50 year event (1% - 2% chance of occurrence).

Figure 7a & b. Flood Frequency Analysis and Hydrograph (USGS, National Streamflow Statistics, 2009). NSS data from USGS- Water Supply Paper 1887, p. 52 (Crippen and Bue, 1977).
